NEW JERSEY EXECUTIVE STATEHOUSE

SUMMARY LETTER

25 JANUARY 2017

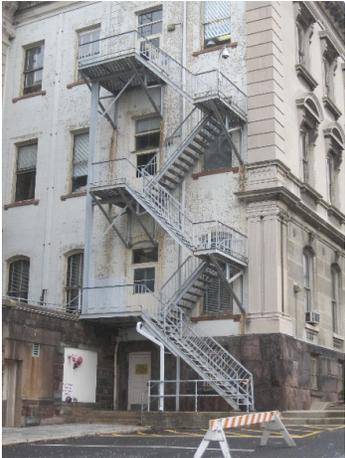
Fire Escape 1.

- Removal of Exterior Fire Stairs 1 and 2 and replacement with a new interim stair tower at the East Lightwell. This is an interim measure and the stairs will be removed when a comprehensive code compliance and evacuation plan is in place as part of a comprehensive renovation of the building.
- Exterior Stairs 3 and 4 are being shored, until a comprehensive renovation is undertaken.
- Cornice stabilization at the SE Wing.
- Localized stucco repairs and stabilization

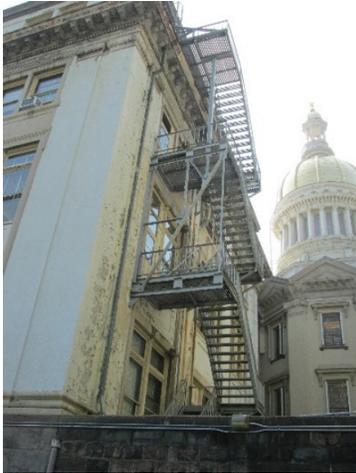
Fire Escape 2.

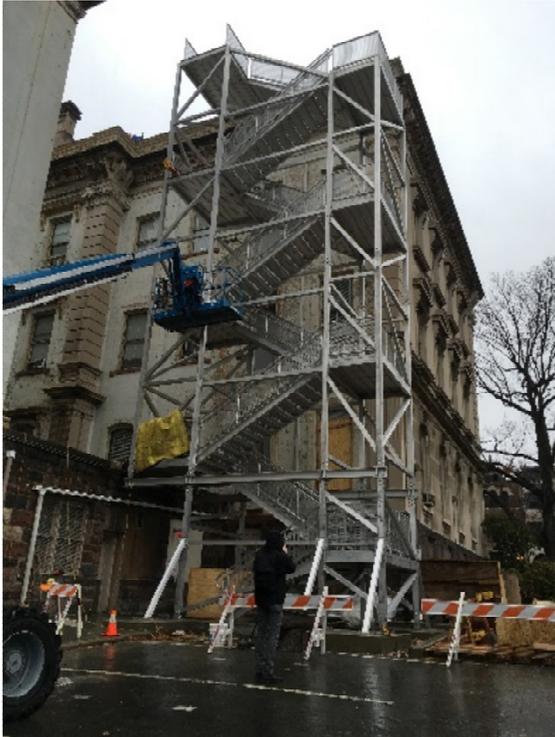
New Temporary Single Fire Escape.

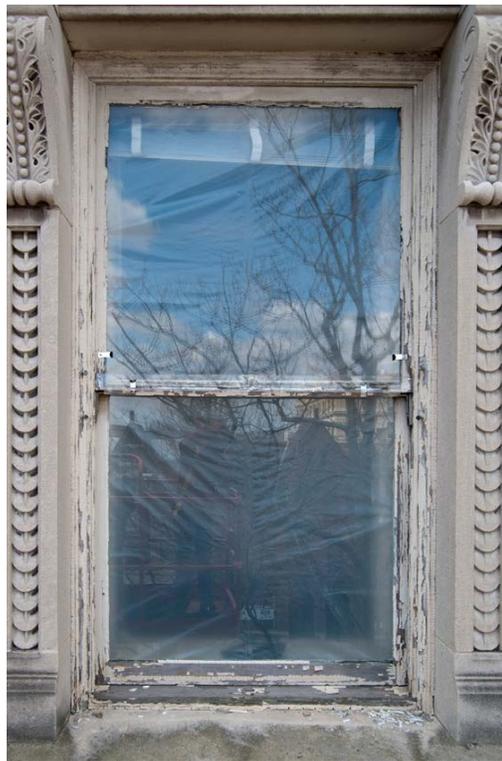
- Removal of eleven historic window sashes at risk of falling out of the frames. Currently, they are held in place with duct tape and clips. The historic windows will be safely stored and will be restored when the comprehensive renovation of the building is undertaken. Interim repairs will be made and temporary units will be installed in the window opening, until permanent repairs are made.

Existing Window.

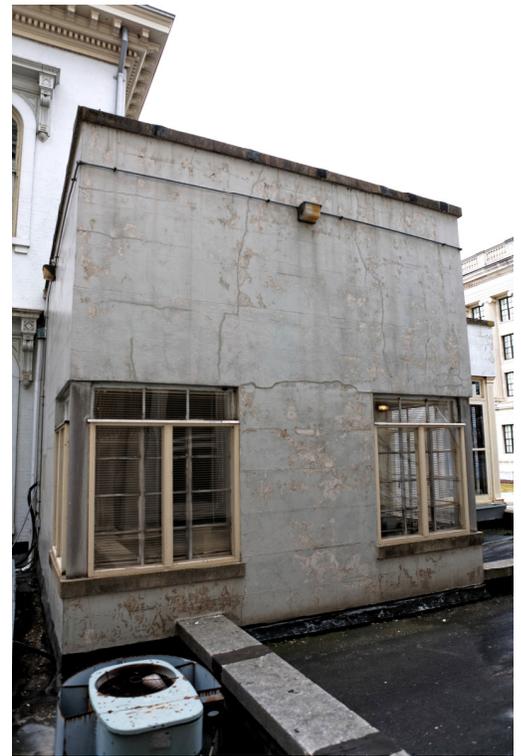
Cracks at Governor's Suite Offices.

- The office additions next to the Governor's Office were constructed in 1944, 1947 and 1958. Our survey confirmed that the walls of these additions bear solely on the roof structure and do not align with the structural beams and columns below but are supported on the concrete roof joists. The existing concrete joists were not designed for this additional load. The observed cracking of the masonry is a reflection of several issues, including:
 - a. Water infiltration from the roof and roof parapet
 - b. Water infiltration at cracks in masonry wall
 - c. Poor masonry work of the wall construction
 - d. Deflection of the lightwell roof joists due to loading
 - e. Deflection of the lightwell roof joists due to long term concrete creep. Creep is deflection under sustained load where long term pressure on the concrete can make it change shape.

Shoring will be installed to provide a short term solution until a permanent structural repair is made.

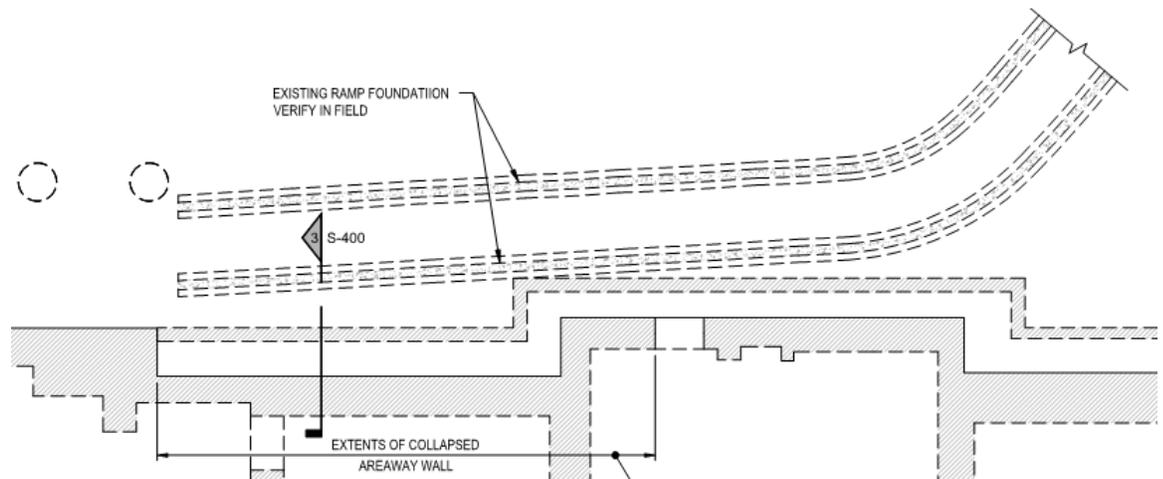
- The basement areaways of the north section of the building, several of which have collapsed, will be stabilized. These areaway walls support the soil that is to the north of the walls, the sidewalk slab on grade to the north of the walls, and the handicapped accessibility ramps. The extent of the collapsed areaway wall is located to the east of the north building entrance. A partial plan of this area is shown below. The collapsed section of areaway supports and is directly behind landscaping and is not readily accessible to the public. The collapse appears to have been caused by the undermining of the existing footing by the ramp foundation that was installed adjacent. The areaway walls themselves are suffering deterioration from their age and lack of maintenance.

Extents of collapsed areaway wall

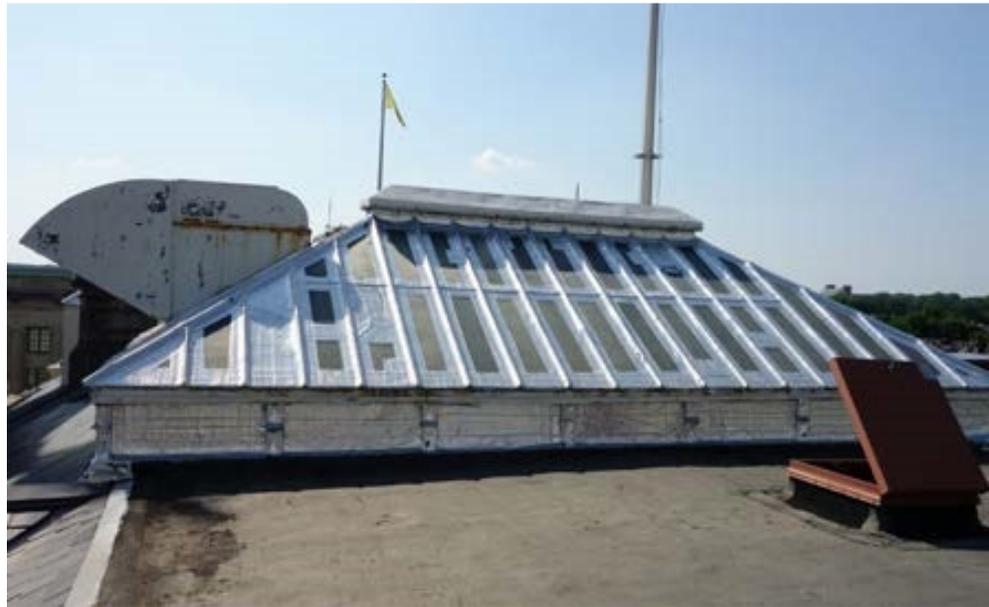
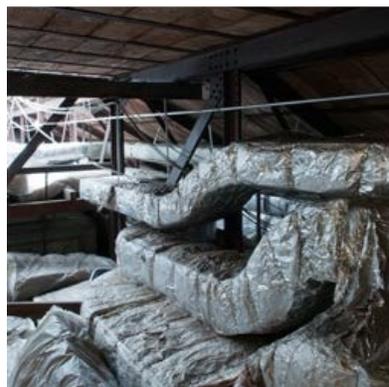
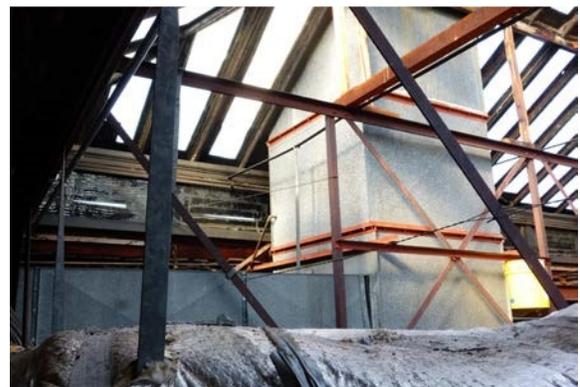
3. Skylights:

All skylights have severely deteriorated and corroded. Inappropriate mechanical interventions have further compromised the architectural integrity of the skylights and impacted the historic laylights

below. The skylights have far exceeded their safe and useful life and must be replaced with new assemblies, which will likely be stronger and heavier than the existing units.

Before new skylights are installed, the existing trusses will require reinforcement to support the heavier assemblies, as well as to comply with contemporary code-requirements for snow and wind loading.

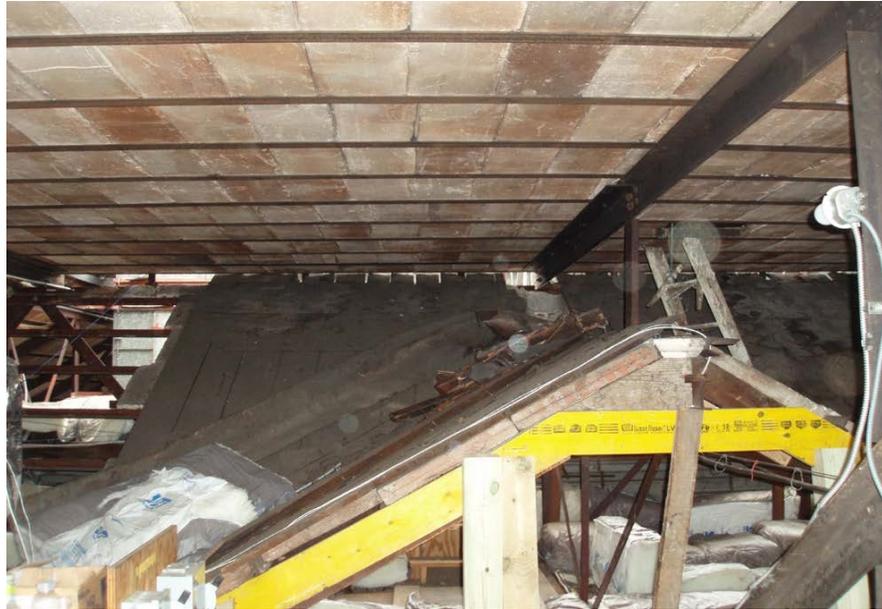
5. North Attic:

In addition to the issues associated with water infiltration, the attic is an area of significant risk. HVAC ducts have been placed throughout the attic without a logic and / or a plan, as individual projects were undertaken over the last 60 years. In addition, the presence of combustible materials - remnants of past building campaigns, i.e. old roofs, etc. - represent a significant life safety risk since there are is no automatic sprinkler system providing full coverage throughout the building.

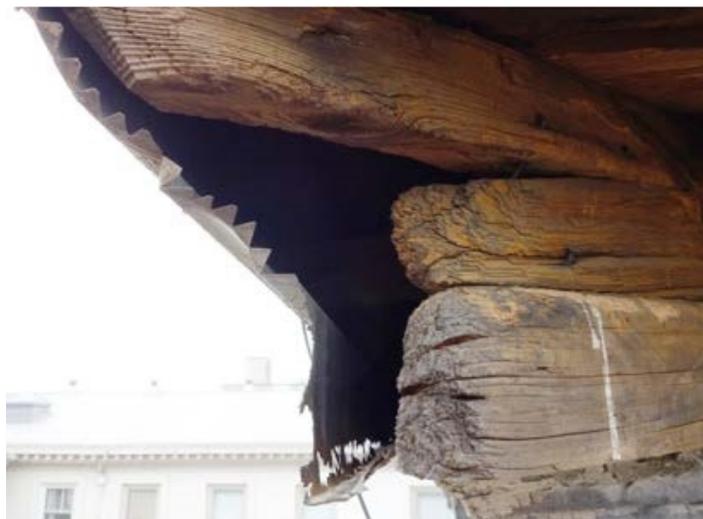
6. Cornices:

All cornices throughout the building require both surface and structural repairs. This is a particularly vulnerable area of the building that requires extensive repairs and intervention. The Southeast wing cornices present the most advanced deterioration and decay.

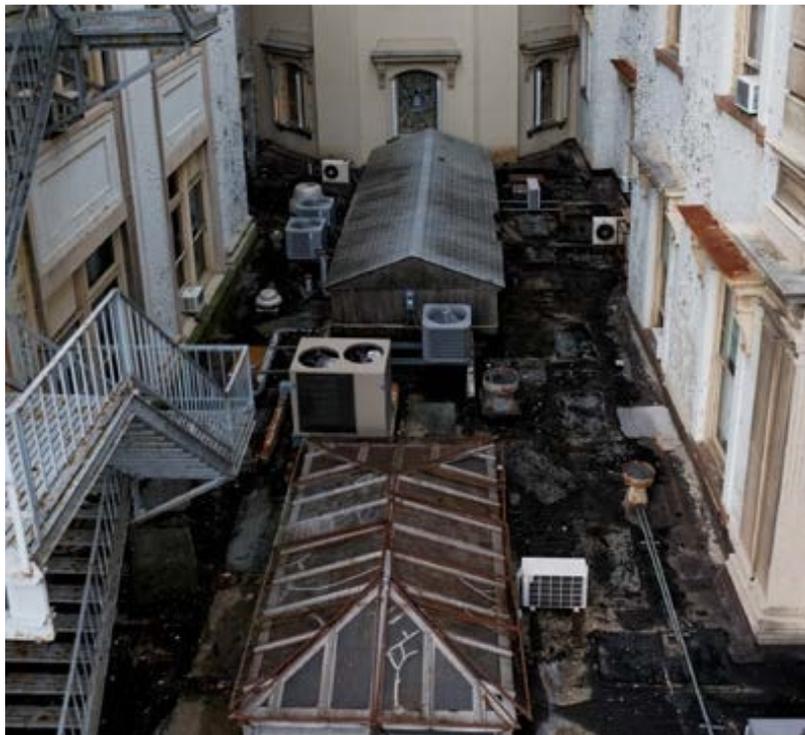
- Concrete core testing indicated that the existing concrete slabs have experienced some carbonation. Carbonation results from exposure to air and moisture and can spread over time. This causes the steel reinforcement to become more susceptible to corrosion, which can impact the slab capacity for supporting loads. [It is important to note that the slabs are already under-designed and they do not meet current code mandated load requirements]

- Finally, since lightwell structures were an “afterthought’ when they were constructed in 1920 and 1944, they were placed within the available dimensional allowances in relationship to the historic window sills, which do not allow for proper flashing and transitions. Replacing the roofing systems without addressing this issue will not address the water infiltration on a long term basis.

East Lightwell.

The east and west lightwells require complete replacement of the existing roofs. The issues associated with this work are as follows:

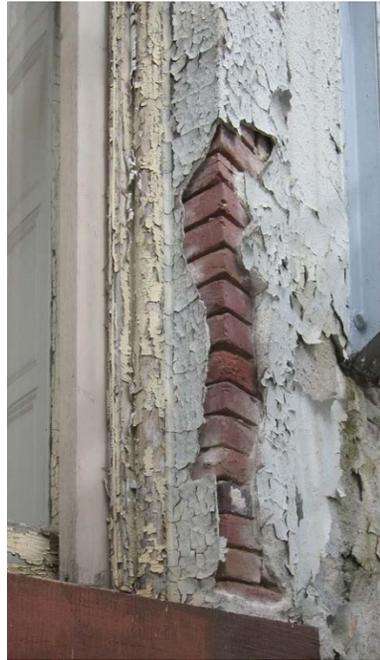
9. Failed Stucco and Masonry Repairs:

- There is extensive stucco failure throughout the building. In addition, the exposed brick masonry has lost its mortar, allowing water to infiltrate throughout the building.
- The failed stucco should be removed carefully until sound stucco is found and brick masonry repairs should be made.

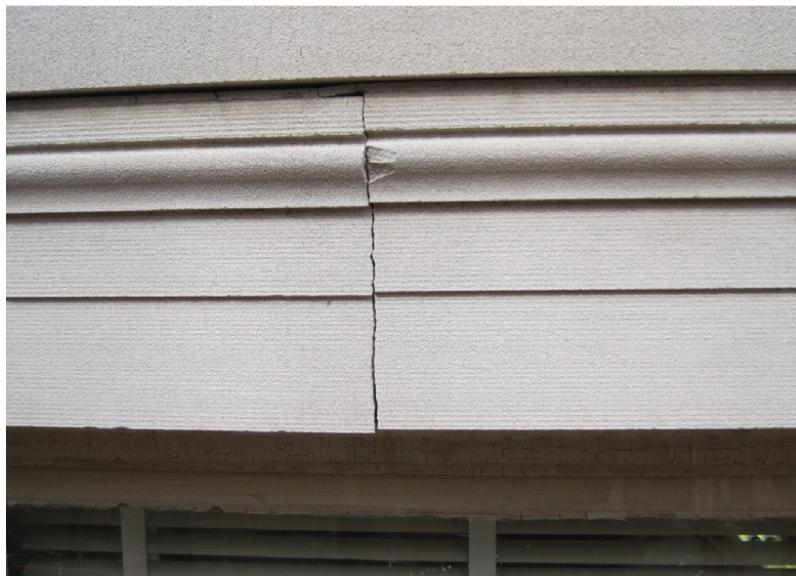
10. Window Lintels:

Several lintels throughout the building present severe deterioration, cracking and in some cases movement. Expensive repairs are required to correct this condition.
