**324 N. Main Street, Davenport IA – Partial Collapse  
Preliminary Investigative Report**

LF232566 / WBG202306  
August 15, 2023

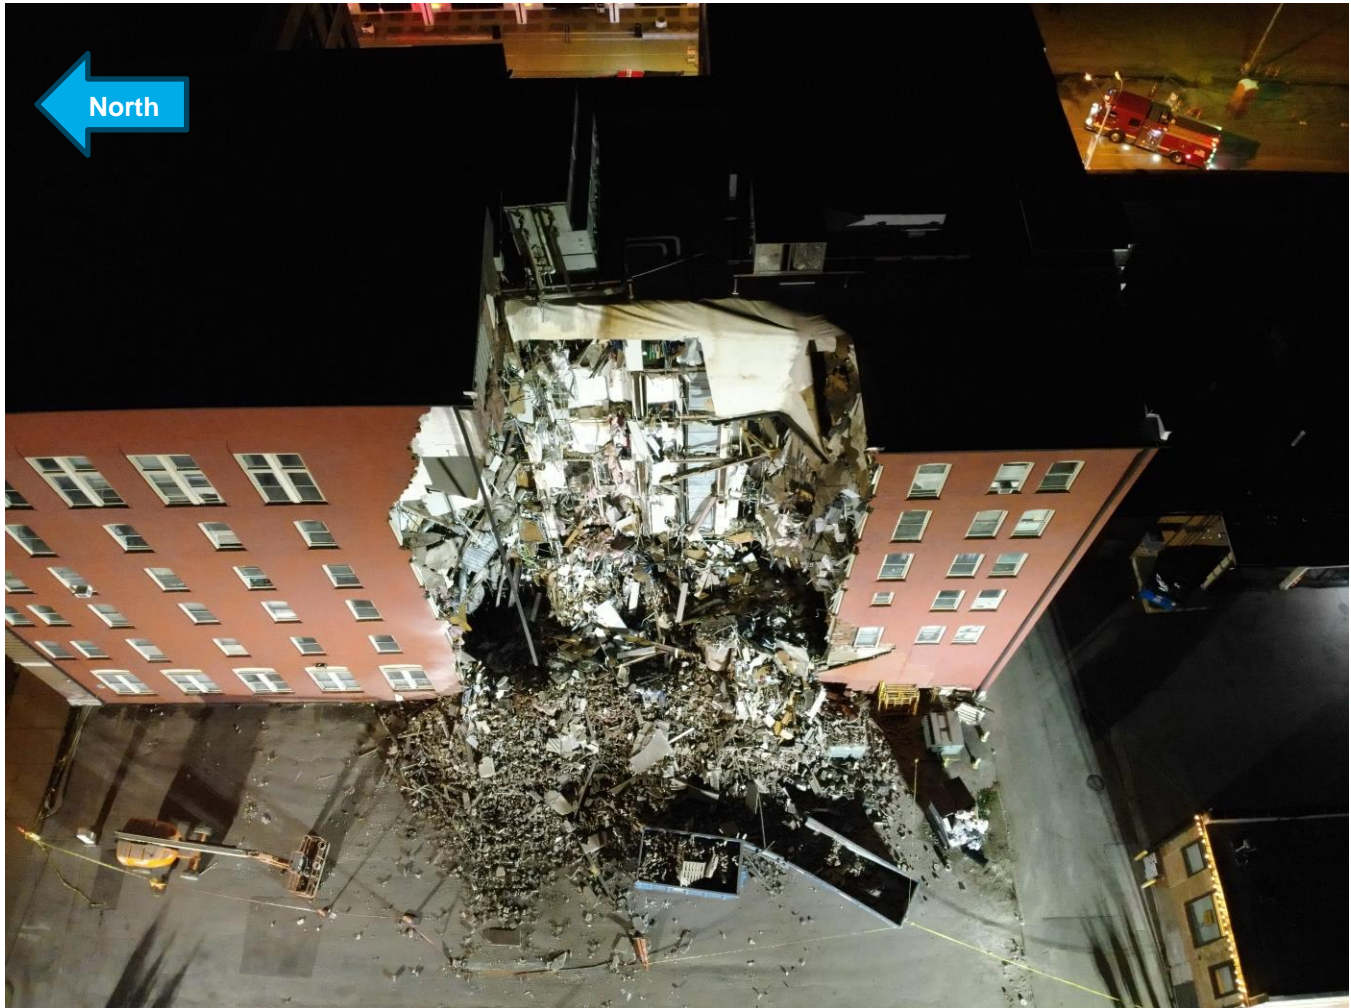
**Fig. 1. Overall aerial view of the partial collapse of the Building (Image from City of Davenport)**

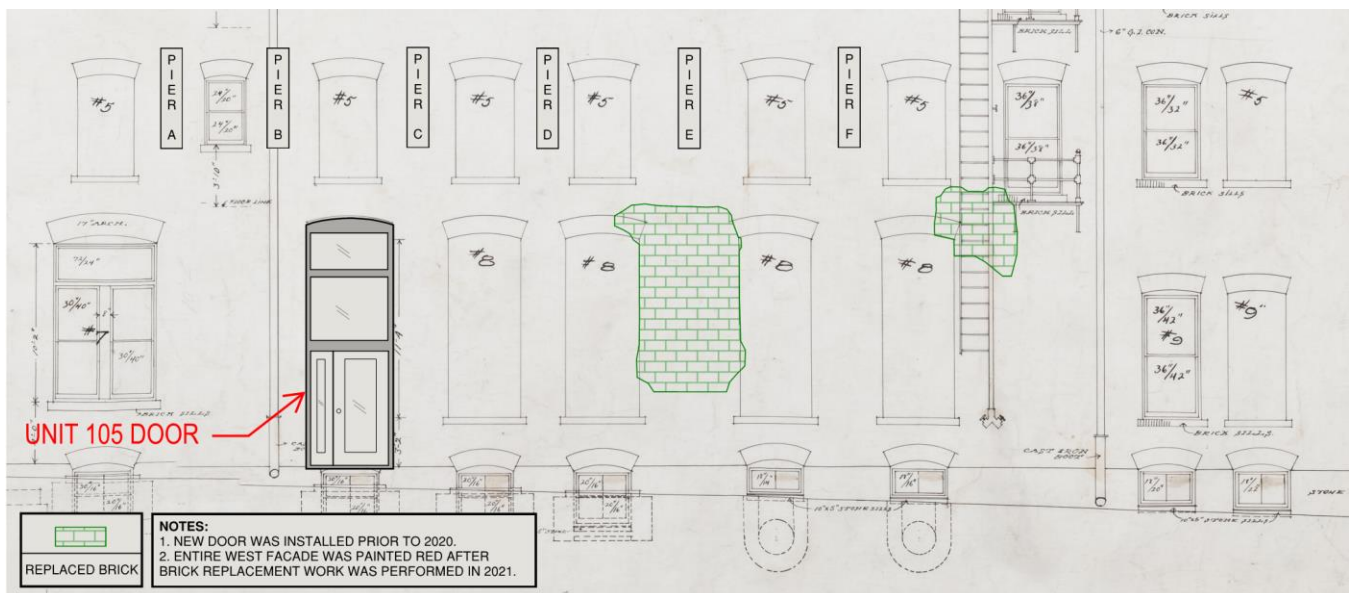
Photographs from late 2020 and early 2021 indicate that two relatively small areas of brick replacement were completed towards the southern end of the west elevation. However, there are no engineering reports or related documents on file that designate the scope or methodology for these repairs. In addition, by May 2021 photographs indicate that the entire west elevation was painted red. **Fig. 6** below provides an excerpt from the original 1906 elevation drawings, annotated with areas of brick replaced during the 2020 and 2021 repair campaigns.

**Fig. 6. Original 1906 west elevation drawing indicating 2021 repair locations (Annotations by WBG/SEI)**

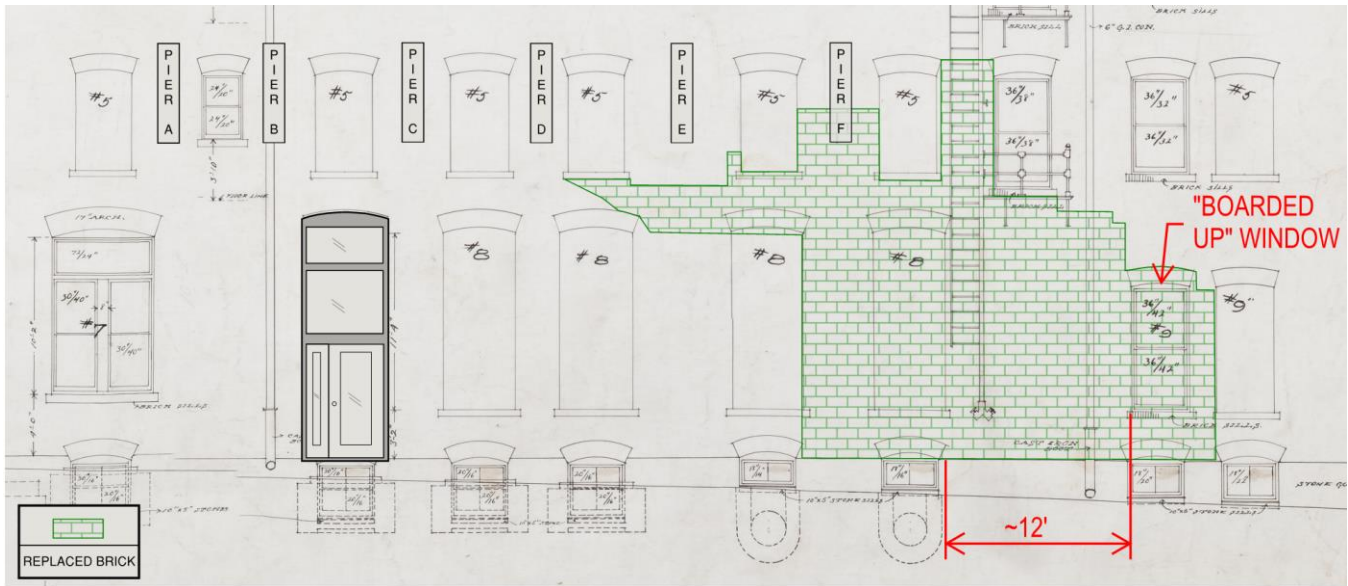
SSE followed up with a second letter dated February 8, 2023, specifying repairs on a 12-foot-wide section of wall to the north of a “boarded-up window” (assumed to be located as noted in **Fig. 7**). The repairs specified the installation of needle beams and steel angles at the second floor to temporarily support the façade during brick replacement in the story below. The full height of wall below the second floor would be replaced with a CMU wall in 4-ft segments. SSE issued an addendum to these repairs on February 28, 2020. The addendum highlighted an unspecified additional segment of wall that would also require replacement due to conditions discovered during the demolition of the originally specified section.

Fig. 7. Original 1906 west elevation drawing annotated with the location of the original “12 Feet” of brick replacement specified by SSE, and the apparent areas of repair completed through May 1, 2023 (Annotations by WBG/SEI)

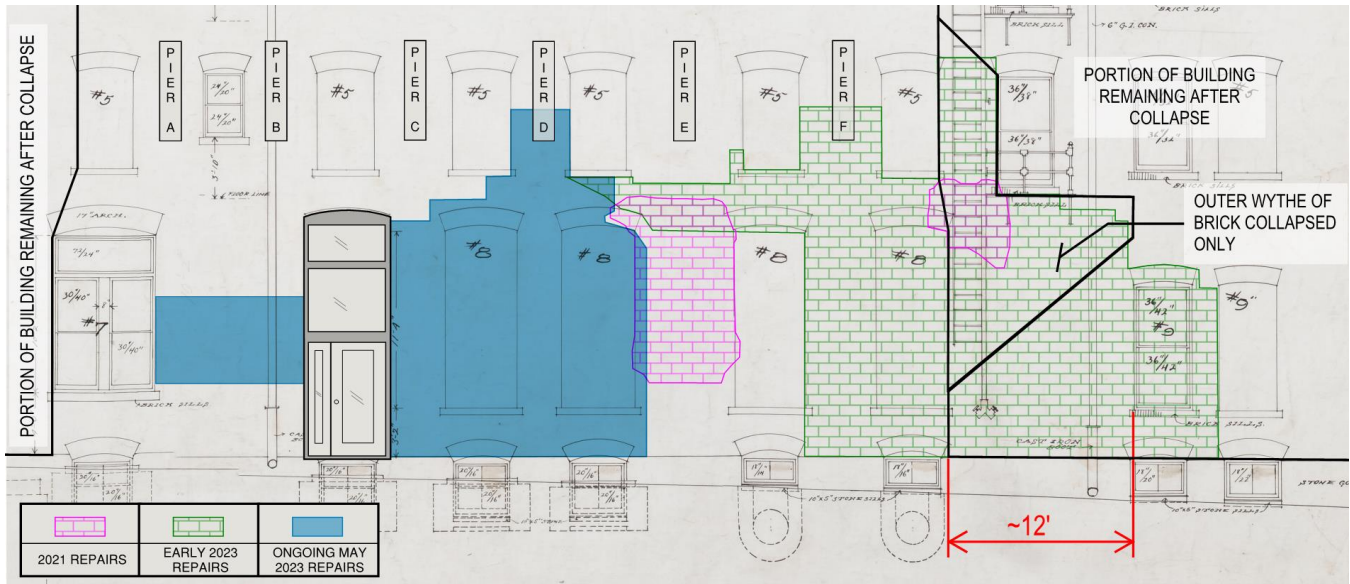
**Fig. 8. Original 1906 west elevation drawing annotated with the various repair programs discussed in this report, in addition to the area of the Building that did not collapse (Annotations by WBG/SEI)**

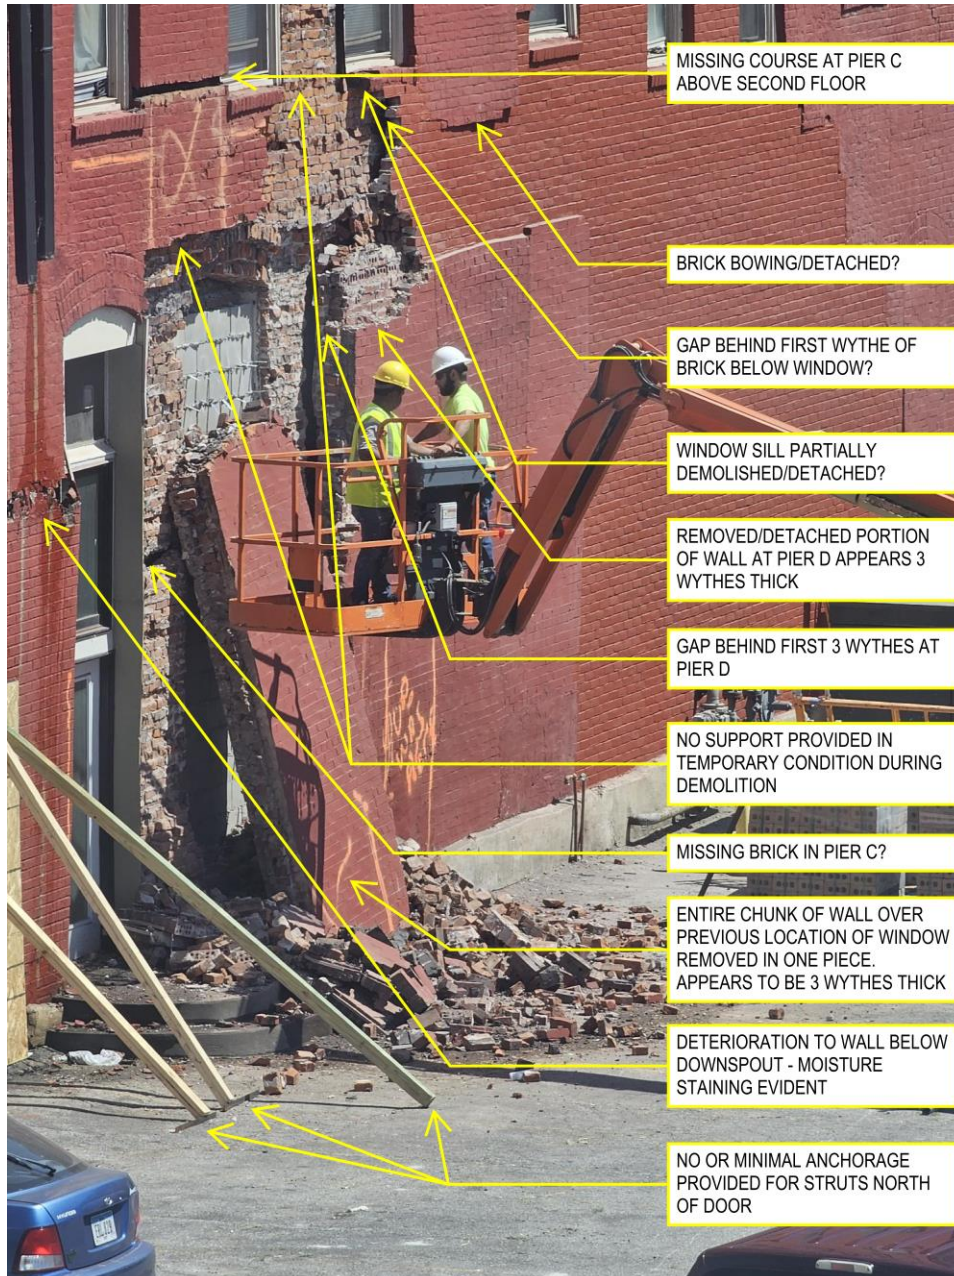
On May 26, 2023 (two days prior to collapse), a photograph was taken of the ongoing repair work at the building. An annotated version of this image is provided in **Fig. 15**. The image indicates several areas of nonconformance with the repair specifications issued by SSE, in addition to other deficient conditions.

**Fig. 15. Photograph from May 26, 2023 at approximately 3pm. Annotation by WBG and SEI.**

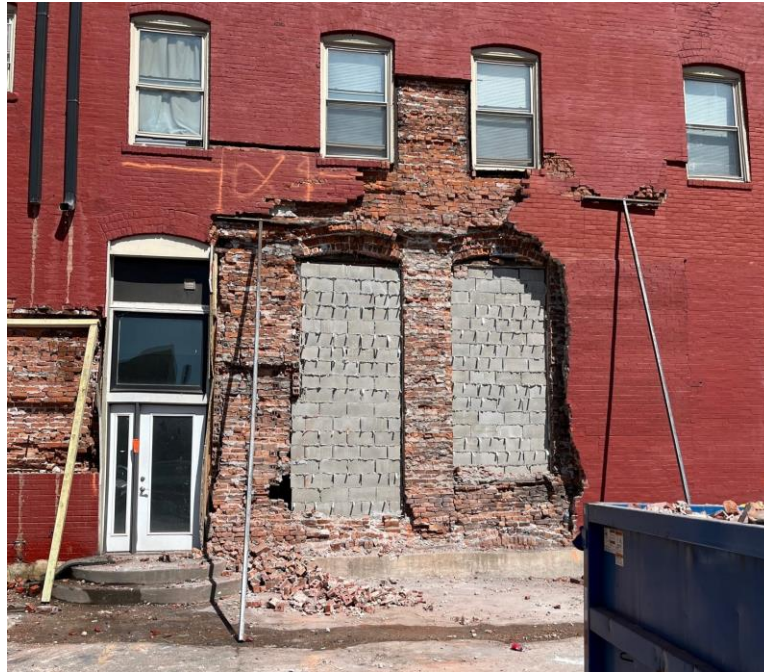
**Fig. 16.** Photograph from May 27, 2023, at approximately 3pm.

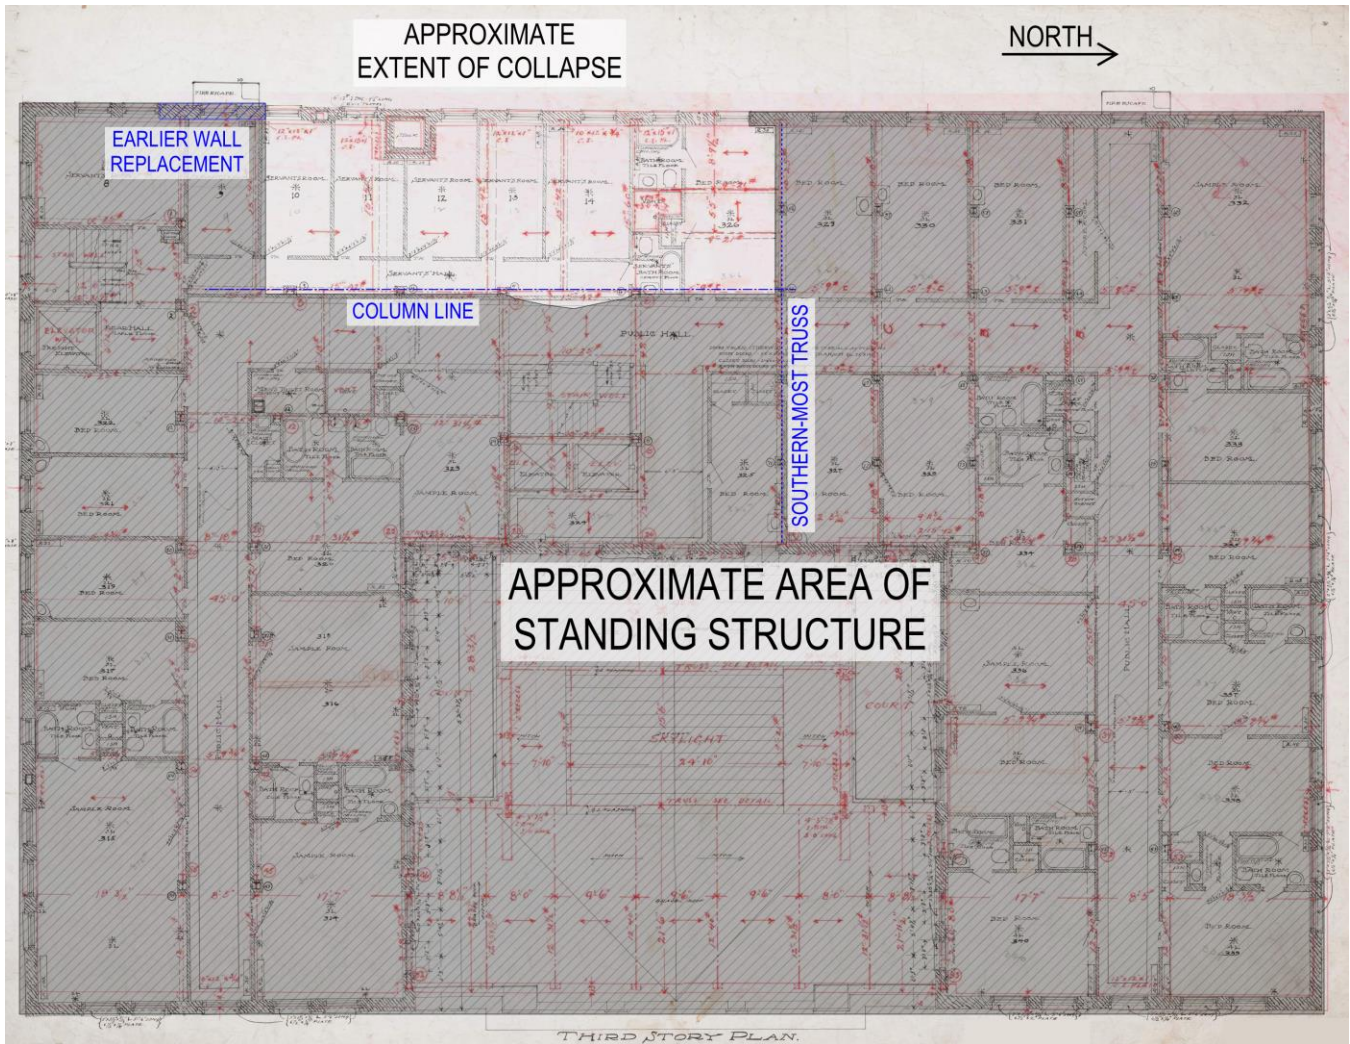
Fig. 19. Third story plan view indicating the portion of the Building that collapsed on May 28, 2023.

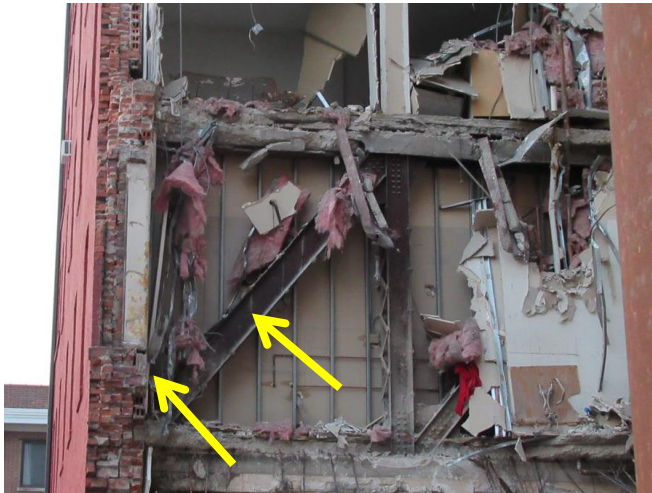
**Fig. 20. Photograph of the northern extent of the collapsed portion of the Building taken June 4, 2023. Arrows indicate steel column (left) and truss (right).**

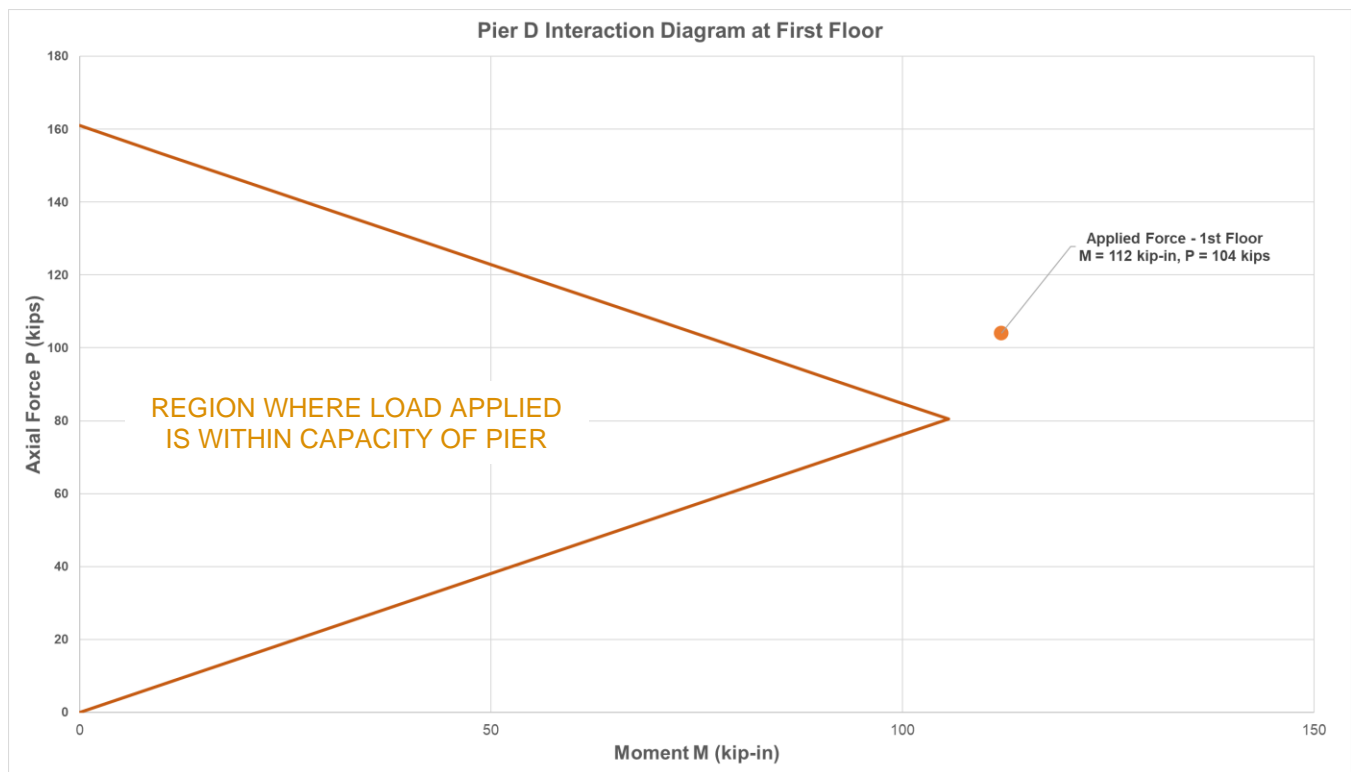
Calculations by WBG and SEI indicate that the removal of the outer wythes of brick demonstrably compromised the wall’s ability to resist the loads on it at the time of collapse, particularly at Piers C and D, such that collapse was imminent. Pier D at the 1<sup>st</sup> floor was the most significantly overstressed (where this tall and narrow pier appears to have been reduced to only two wythes thick (see Fig. 23). Pier D at the 2<sup>nd</sup> floor was also marginally compromised. Pier C was similarly overstressed (note that the wall at this location also featured voids that would have significantly reduced the capacity beyond that assumed in this analysis).

Fig. 24. Interaction Diagram for Pier D at the First Floor

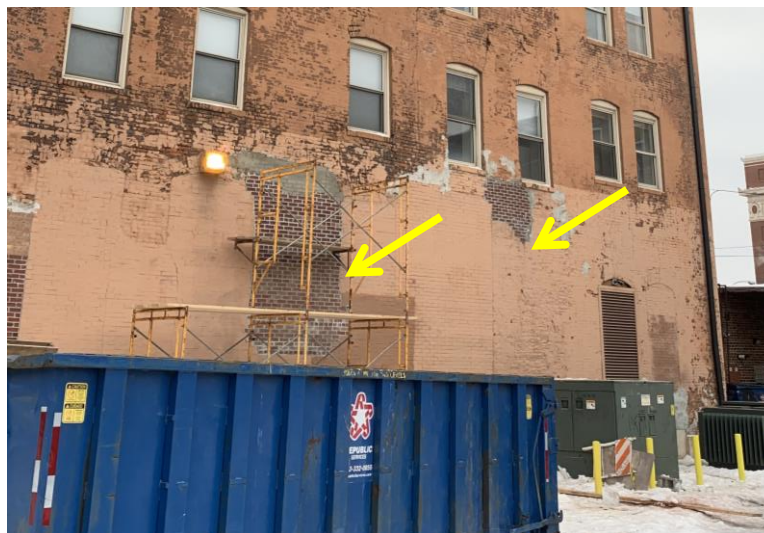
**Fig. 27. West elevation photographs. (Ref: City Inspection Report, Task ID: 20-83090). Yellow arrows point to areas of apparent repair.**

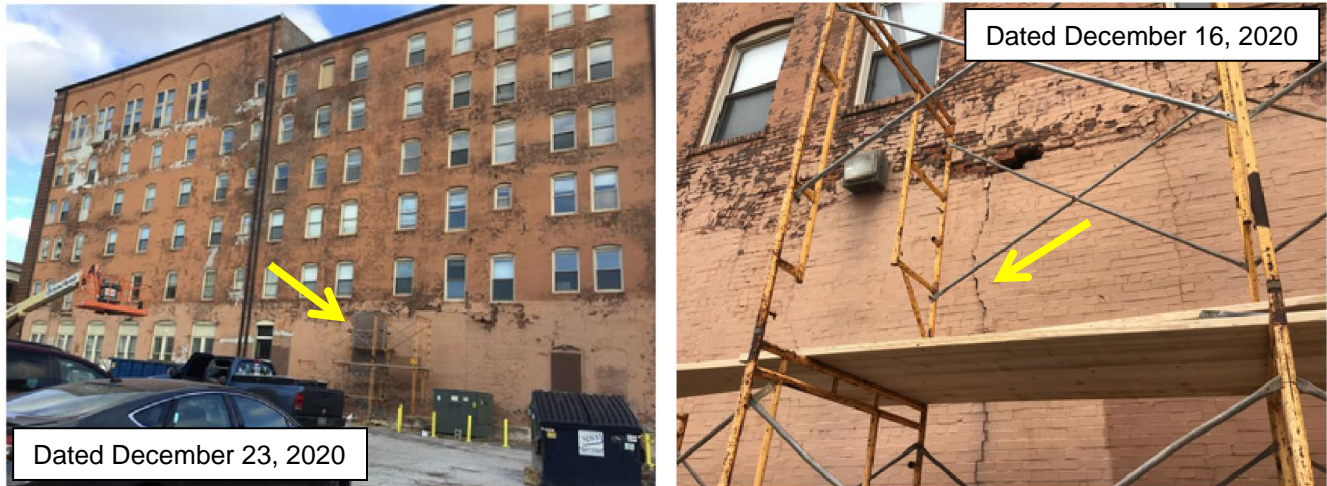
On February 16, 2021 Davenport Neighborhood Services Department again issued a follow-up notice titled “Notice of Extension”. The letter granted additional time for the Building owner to correct code violations. The notice stated that work at the exterior wall “*must be permitted and scheduled as specified by the structural engineer’s report. Work must have started prior [to] May 14, 2021 re-inspection date*”. Additional photographs attached to the notice exhibit some scaffolding erected on the west elevation of the building at the location of a crack in the exterior brick (dated previous to the date of the letter). Other photographs indicate numerous incidents of missing, loose, and delaminated brick on the west elevation.

**Fig. 28. West elevation photographs (Ref: City Reinspection Report, Task ID: 20-72033). Yellow arrow indicates crack in wall.**

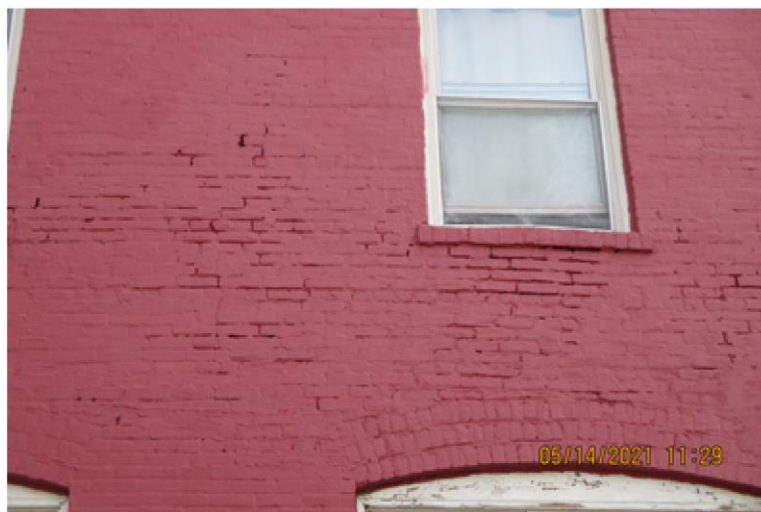
On May 26, 2021 another “Final Official Notice” was issued by the Davenport Neighborhood Services. The report again cited that the exterior wall repair work was in violation. **Fig. 29** is an image associated with this report that indicates the west elevation was painted over by this time.

**Fig. 29. Image of the west elevation indicating brick painting completed on May 14, 2021 (Ref: City Reinspection Report, Task ID: 21-9198).**

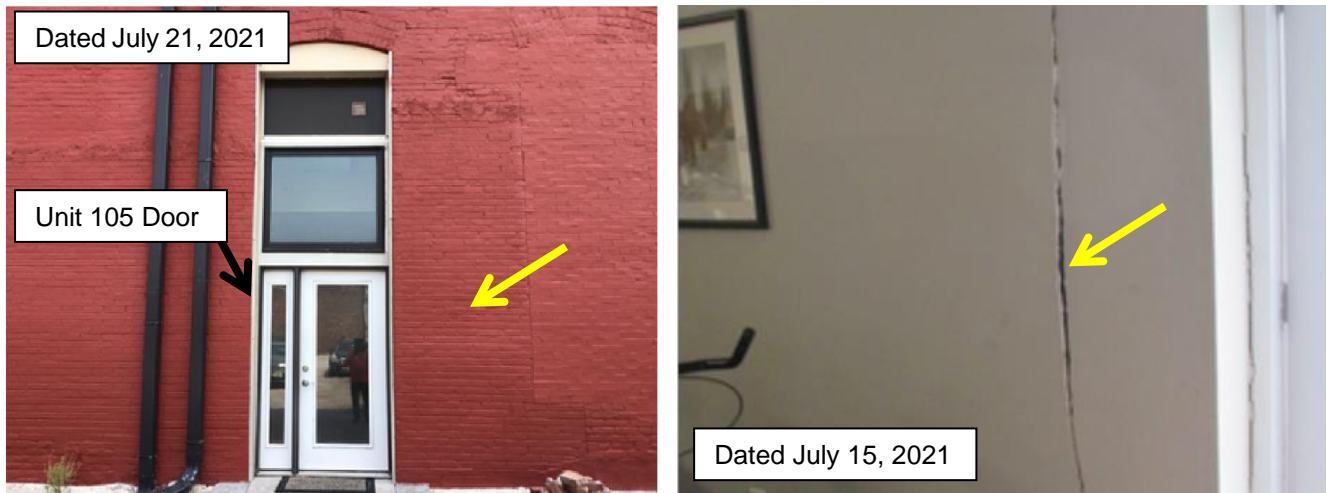
On July 19, 2021 a “Complaint Notice and Order” was issued which cited further deficiencies with the western elevation, specifically around the entrance door to Unit 105. The report stated, “*structural engineer’s report required on west wall structural integrity with scope of work required to make proper repairs*”. An email attached to the report also stated the drywall around the door to the parking lot was not stable and the door was very difficult to open. Images from the report exhibiting the exterior door and a crack in the drywall behind the brick to the south of the door are displayed in **Fig. 30**.

**Fig. 30. Image of the west elevation adjacent the rear door, taken in July, 2021 (Ref: City Reinspection Report, Task ID: 21-42476). Yellow arrow points to apparent location of drywall crack at interior and exterior.**

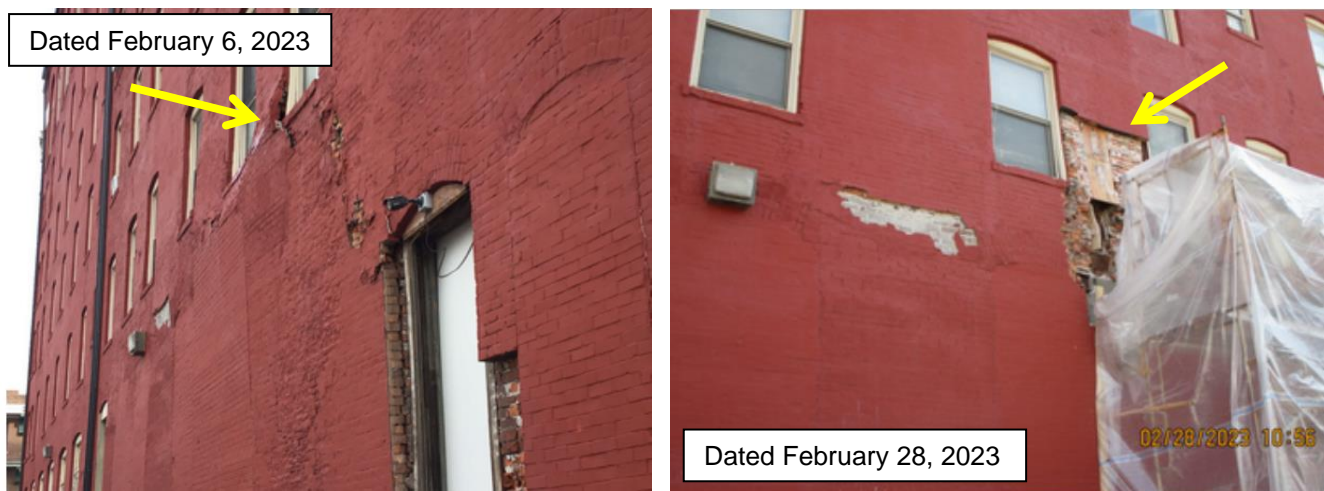
Select photographs from the report are included in **Fig. 33**. The photographs indicate areas of distress observable in the wall in early February. Later in the month a scaffolding was erected and some brick removal was underway.

**Fig. 33.** Image of the west elevation adjacent to the rear door taken in February, 2023 (Ref: City Reinspection Report, Task ID: 21-6454). Yellow arrow points to apparent location of deterioration of the brick and later replacement in progress.

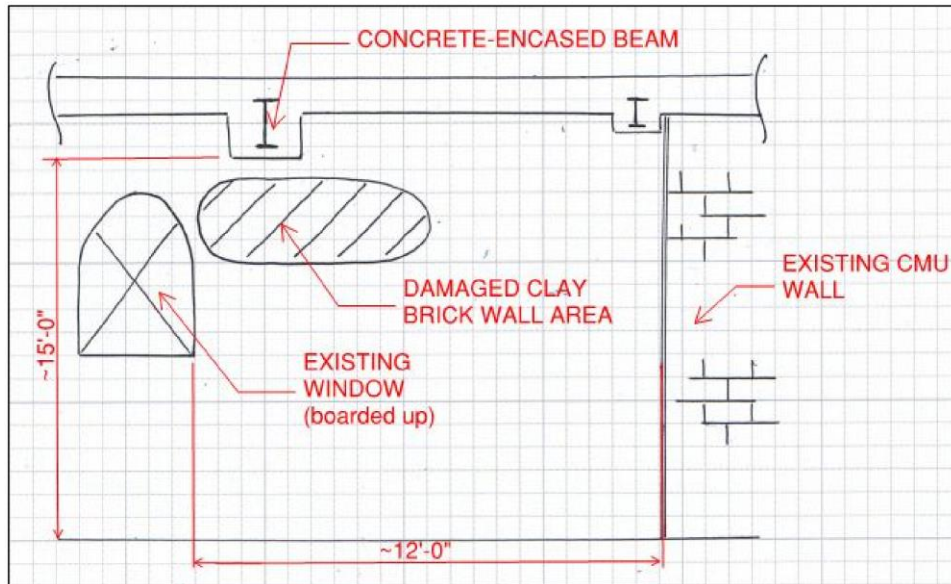
Figure 1 – Current Wall Condition

Figure 1 from the letter (included as **Fig. 34** in this report) indicates the extents of the observed distress (and therefore area of repair) as viewed from inside the building.

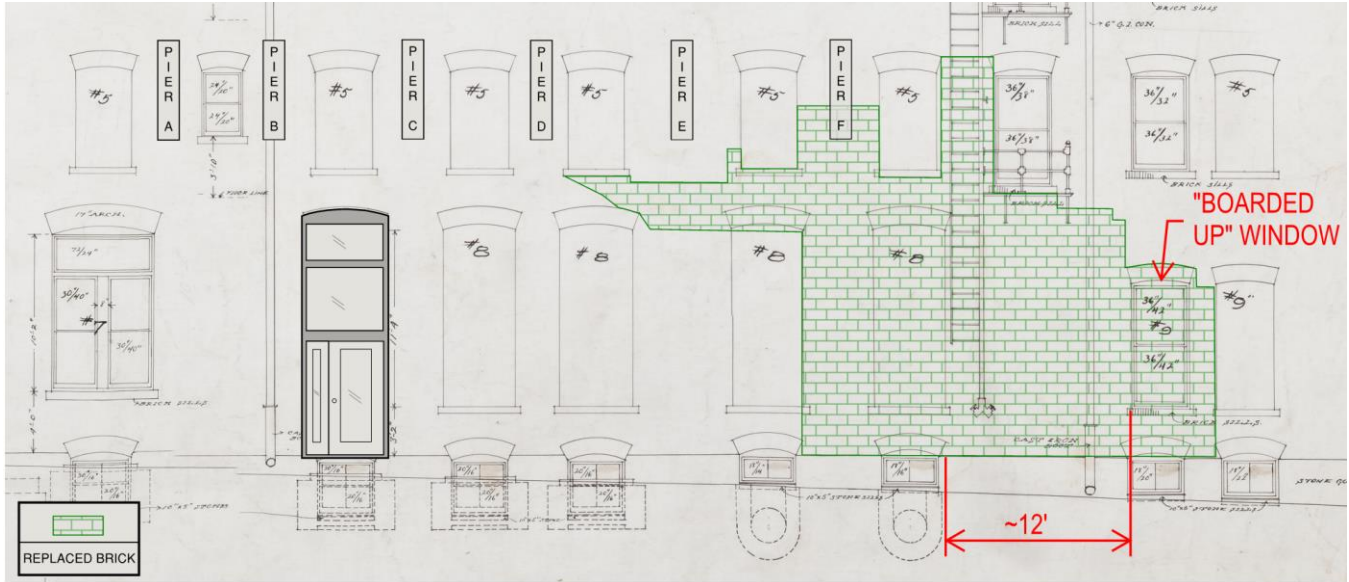
**Fig. 40. West elevation markup indicating actual apparent areas of work completed through May 1, 2023.**

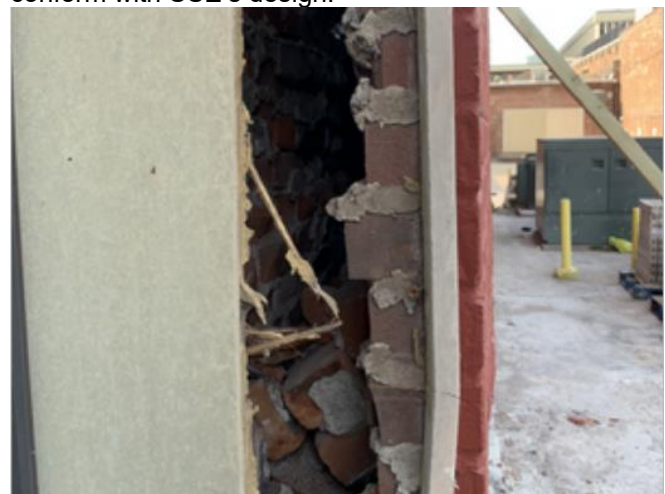
Detail view of bowing brick at south jamb of doorway. Note bricks accumulated in gap between wythes.

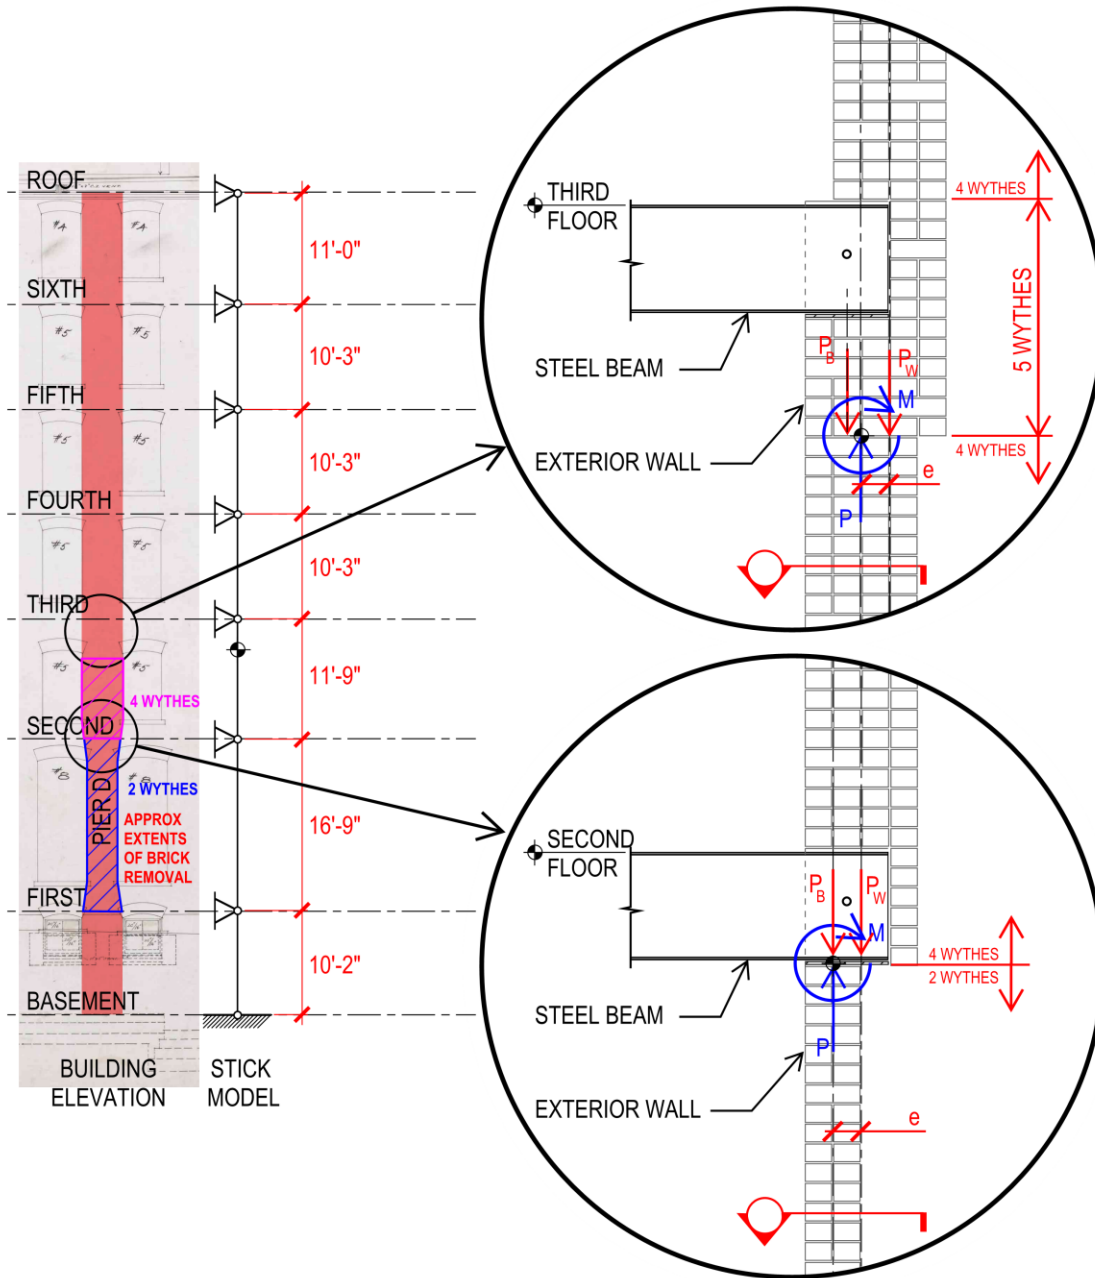
**Fig. 44. Wall sections at areas of removed brick at Pier D**

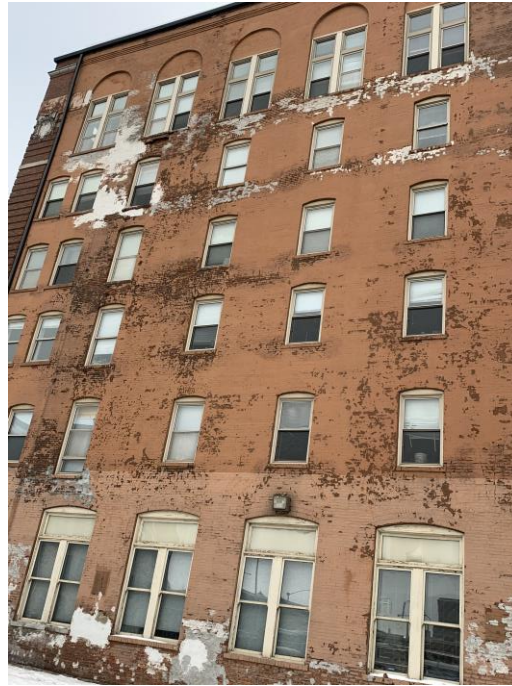
**Photograph 5: 2021 image from City report.**  
Note masonry deterioration throughout west elevation.

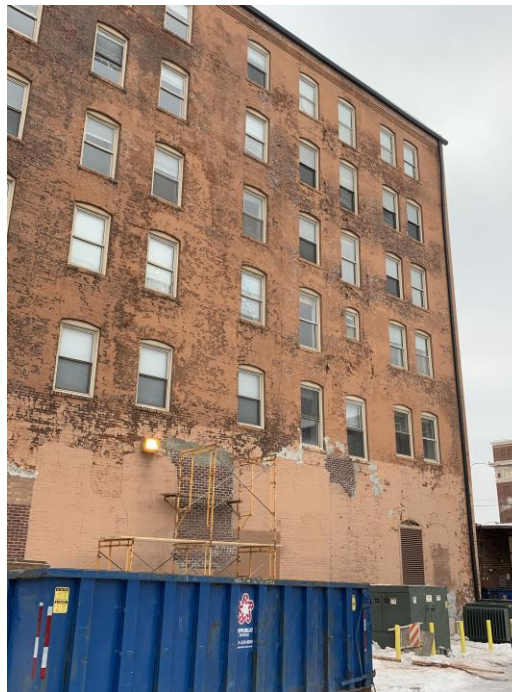
**Photograph 6: 2021 image from City report.**  
Note in progress limited repair work.

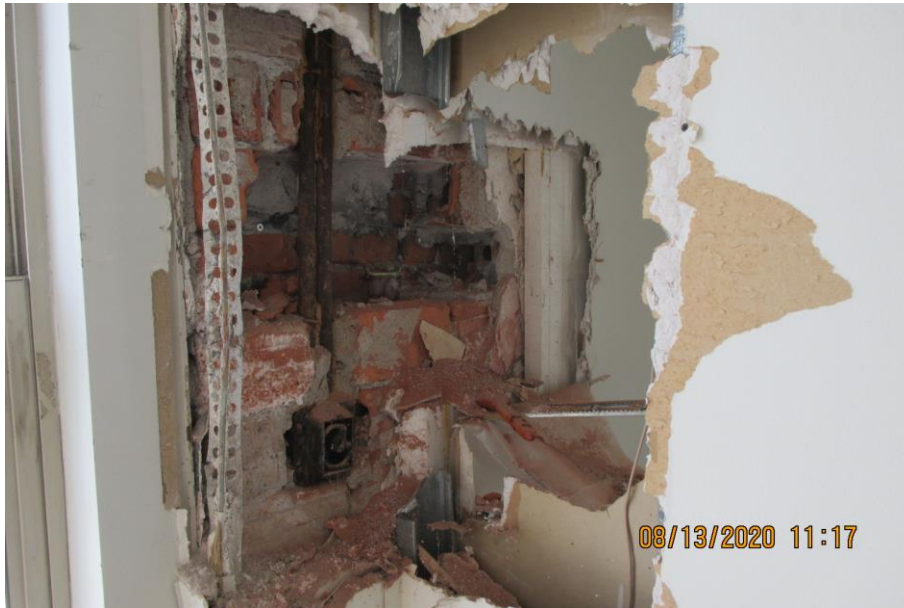
**Photograph 7: August 2020 Image from City report.**  
Note deterioration of brick masonry at interior wythes.

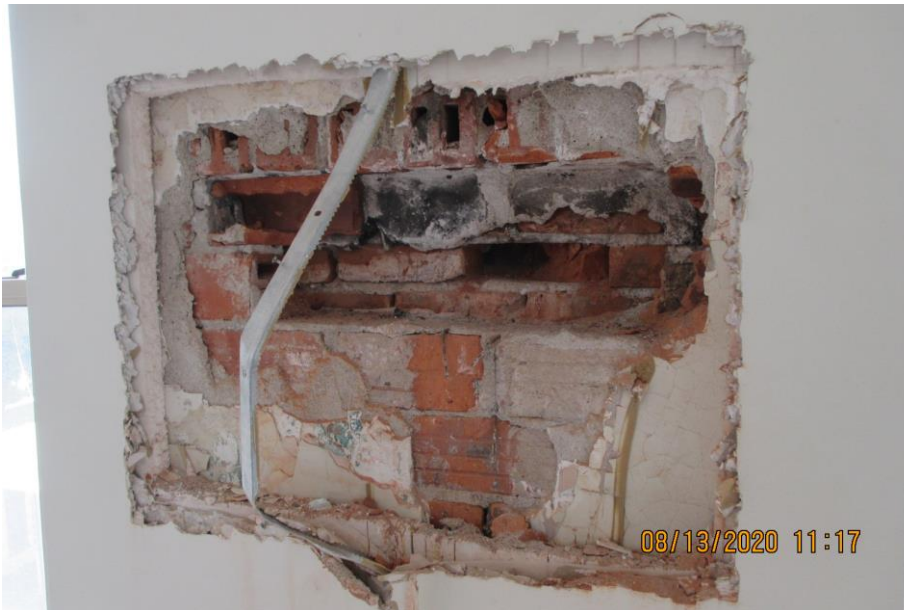
**Photograph 8: August 2020 Image from City report.**  
Note deterioration of brick masonry at interior wythes

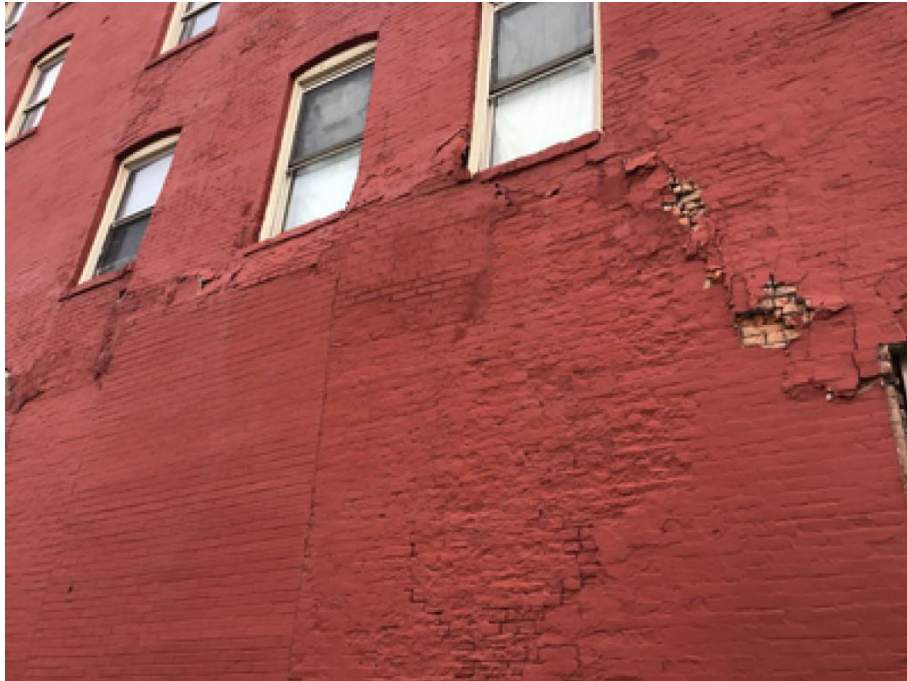
**Photograph 9: February 2023 image from City file 23-6454.**  
Note shear cracks and displaced masonry.

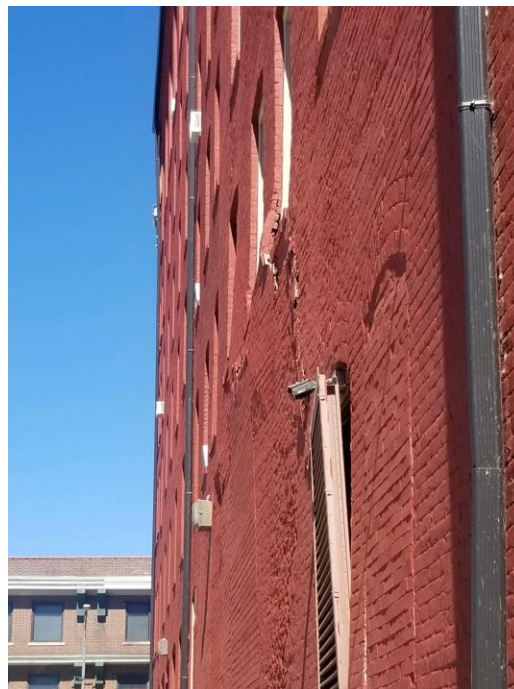
**Photograph 10: February 2023 image from City file 23-6454.**  
Note displaced masonry and louvers.

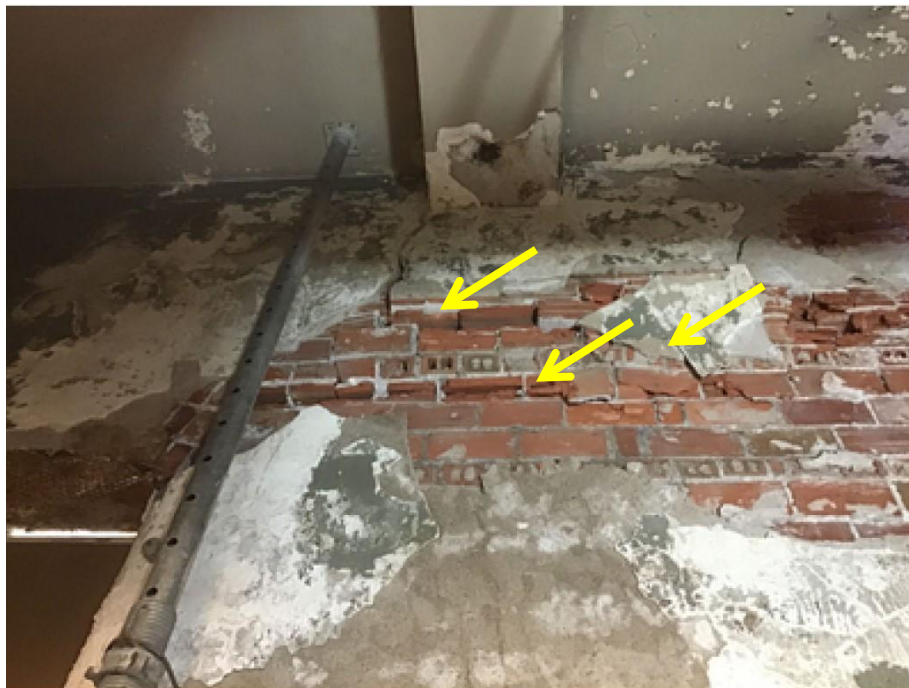
**Photograph 12: February 2023 image from City file 23-6454.**  
Note shear cracks and distress at interior masonry.

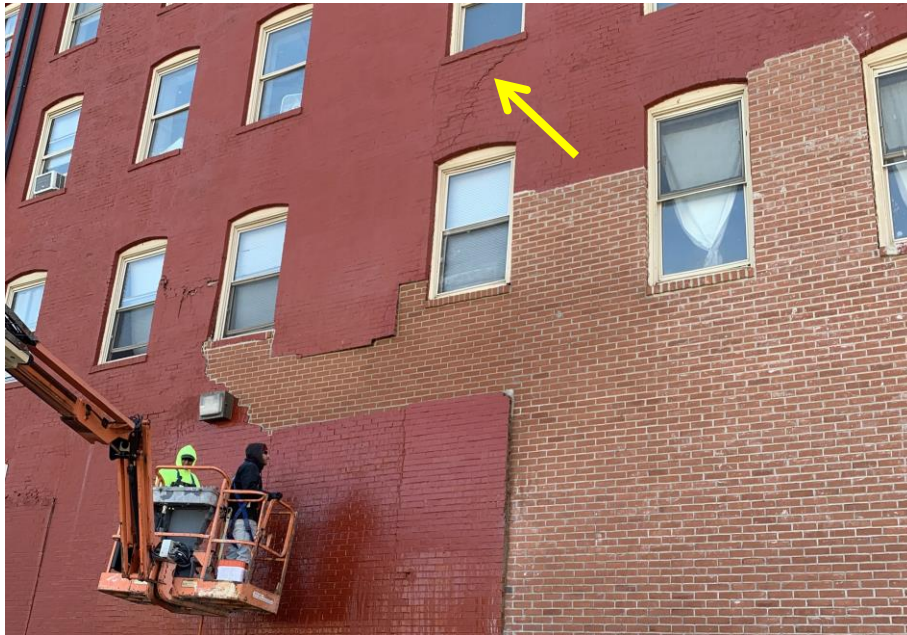
**Photograph 13: May 2023 brick replacement.**  
Note shear crack at spandrels.

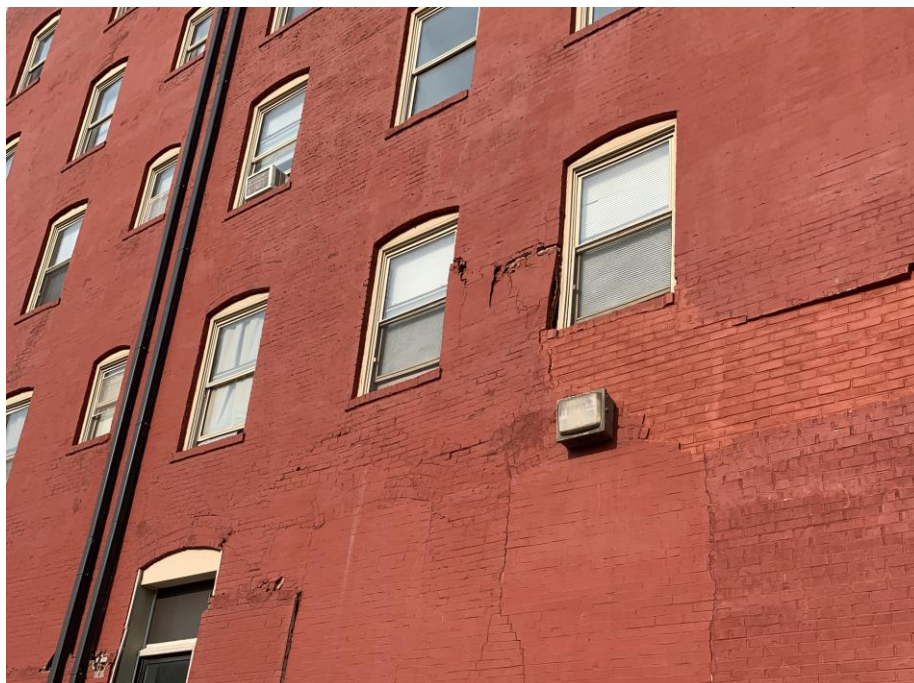
**Photograph 14: May 2023 image of west elevation.**  
Note masonry distress at Piers C and D.

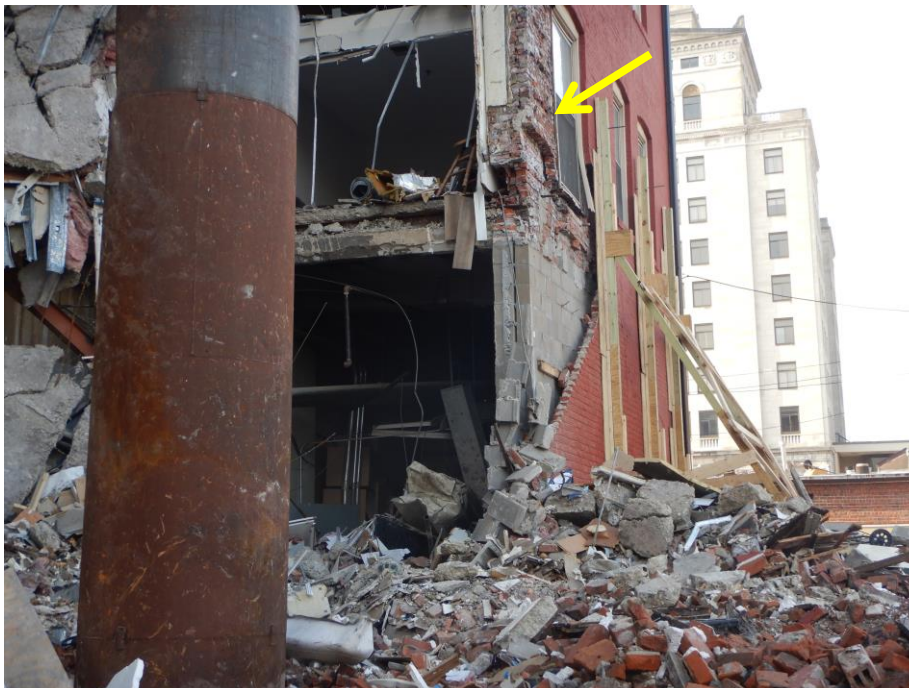
**Photograph 18: Post-collapse view at wall cross section.**  
Note outer 2 wythes of brick masonry not bearing on CMU replacement wall.

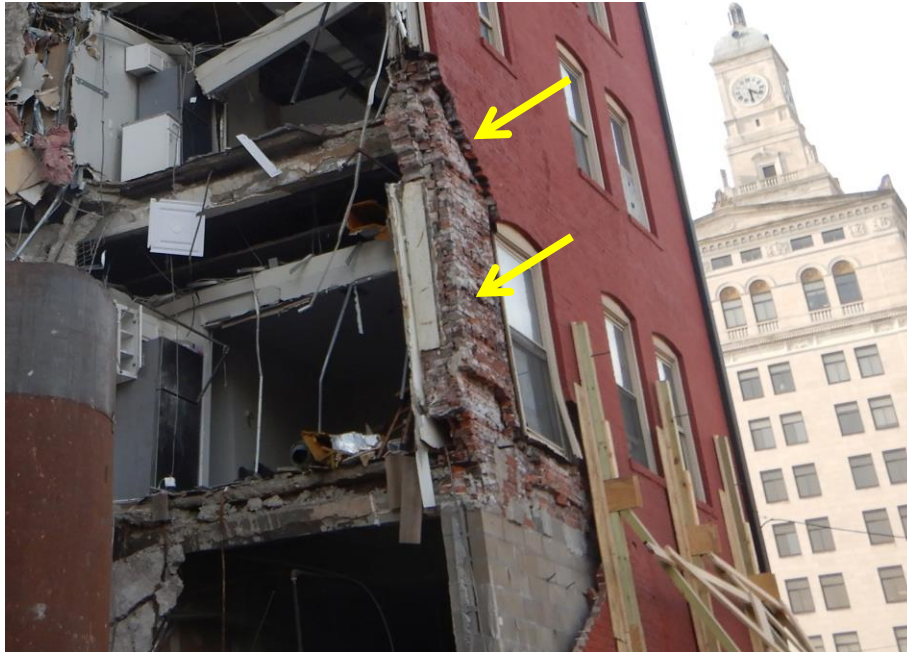
**Photograph 19: Post-collapse view at wall cross section.**  
Note outer 2 wythes of brick masonry not bearing on CMU replacement wall.

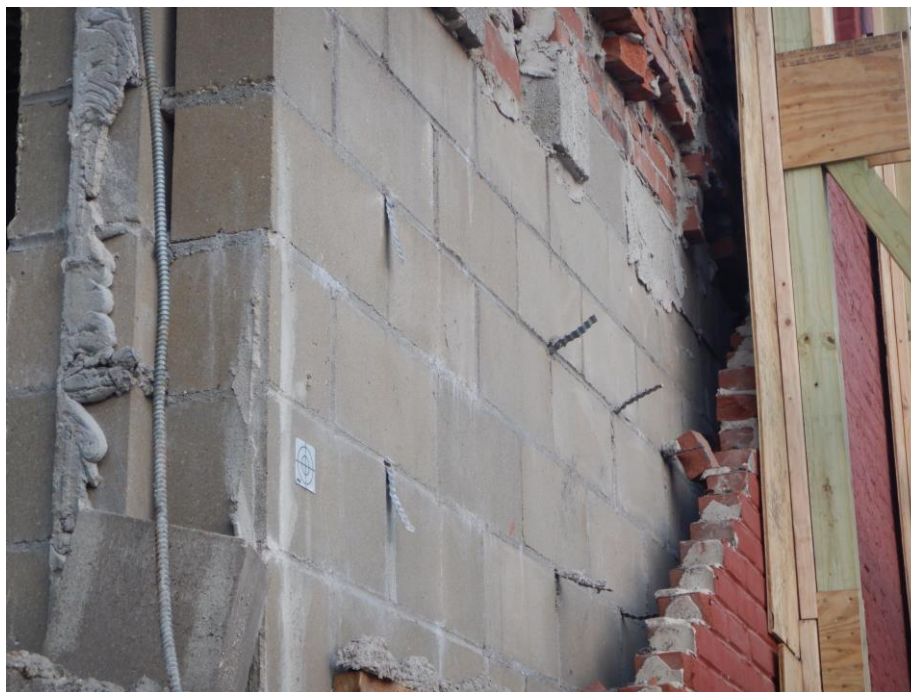
**Photograph 20: Post-collapse image of CMU wall constructed in May 2023.**  
Note corrugated brick ties not engaging outer wythe of brick masonry.
