**324 N. Main Street, Davenport IA – Partial Collapse  
Preliminary Investigative Report**

LF232566 / WBG202306  
August 15, 2023

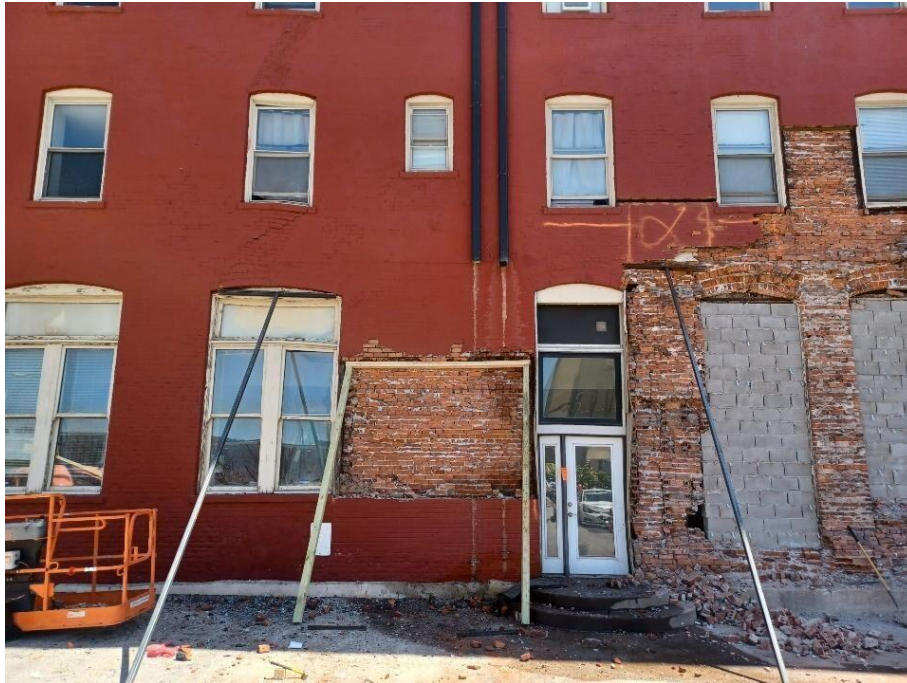
**Photograph 23: Image from June 1, 2023 Quad City Times article, taken by R.A. Masonry.**  
Note improper and inadequate shoring components.

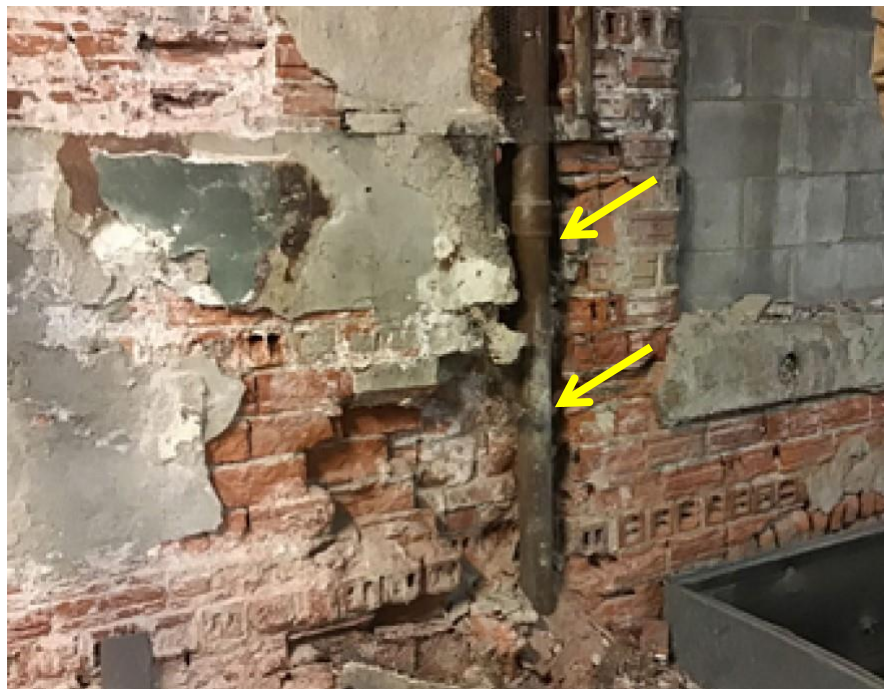
**Photograph 24: Interior photo of west elevation wall from City file 23-6454.**  
Note reduced wall thickness at location of plumbing embedded within wall.

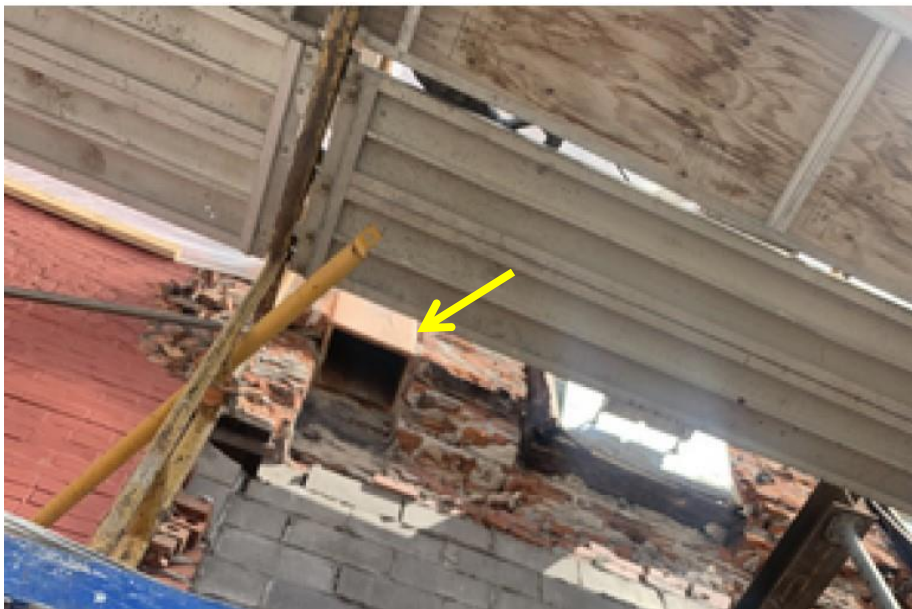
**Photograph 26: Image from City file 23-9778 exhibiting April 2023 repair work.**  
Note large vertical chase embedded within wall at Pier F.

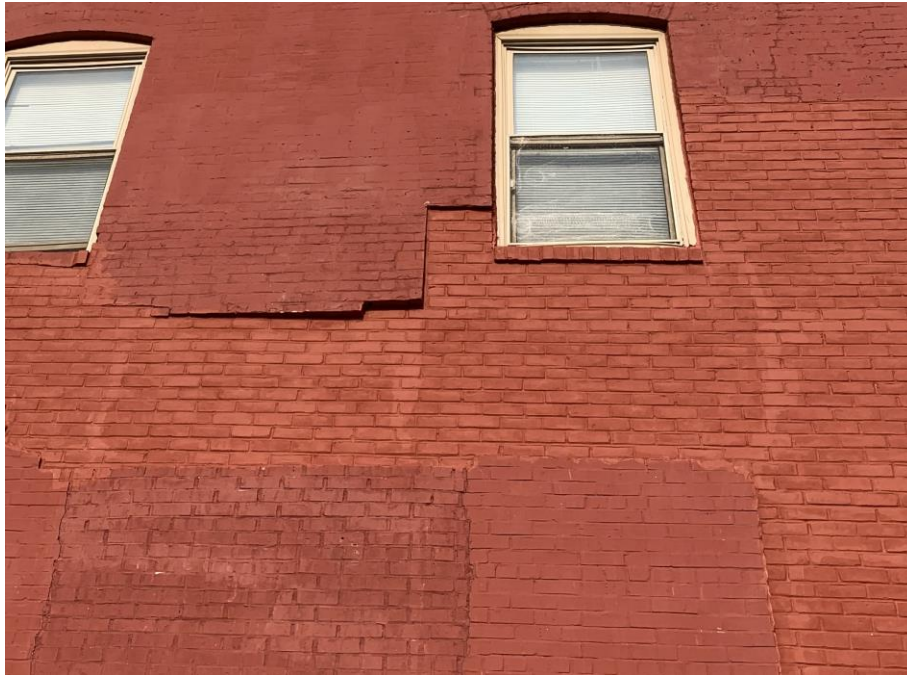
**Photograph 27: Image from City file 23-30329.**  
Note mis-aligned masonry at Pier E brick replacement locations.

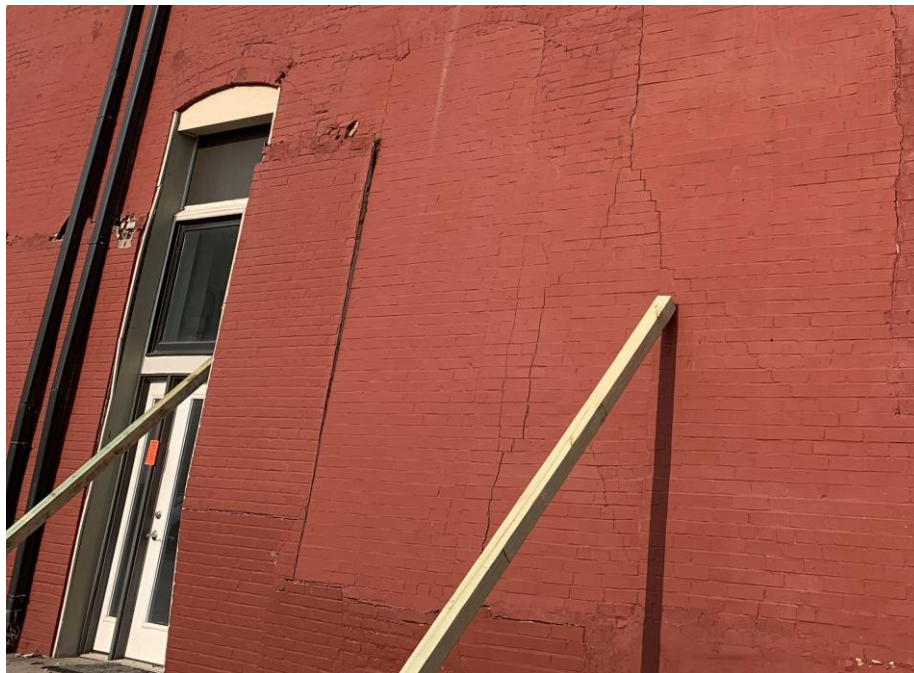
**Photograph 28: Image from City file 23-30329.**  
Note mis-aligned masonry at brick Piers C and D.

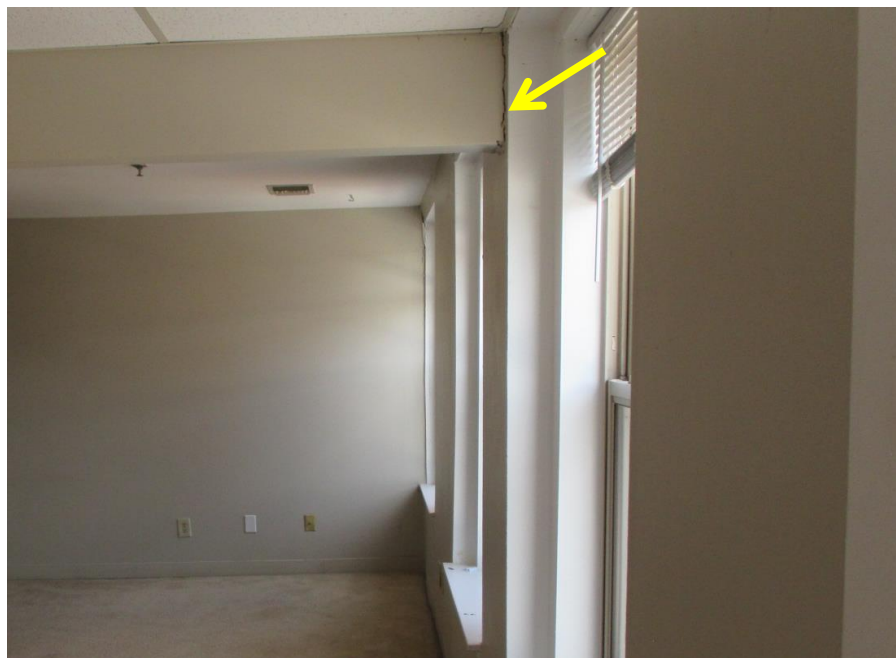
**Photograph 30: Image from City file 20-7839.**  
Note separation of gypsum board at beam to wall interface.

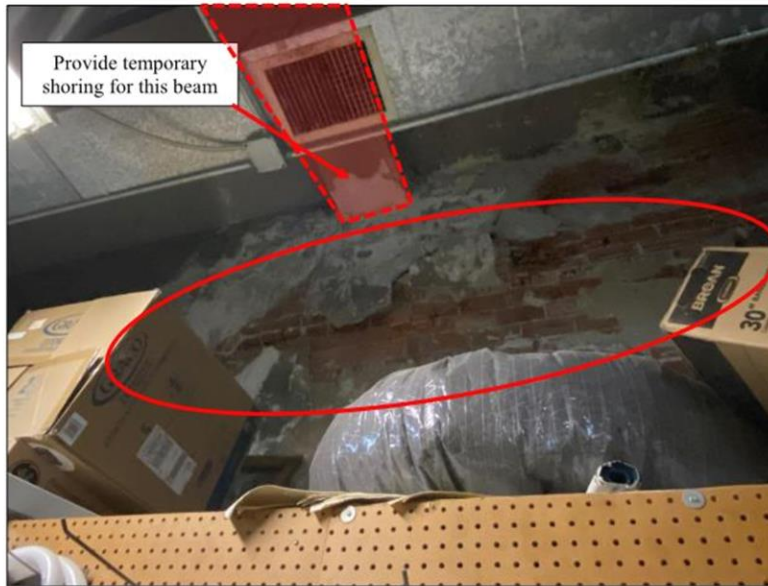
Photo 1 – Damaged Brick & Beam to Support
