**324 N. Main Street, Davenport IA – Partial Collapse  
Preliminary Investigative Report**

LF232566 / WBG202306  
August 15, 2023

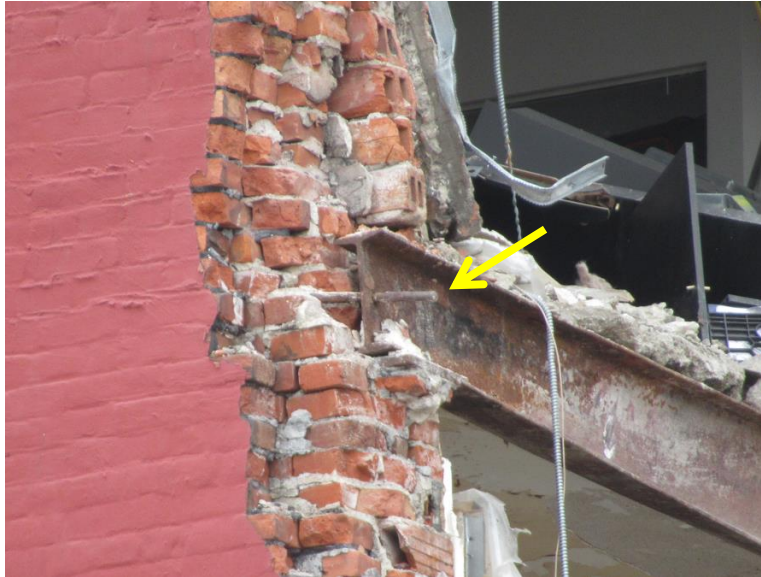
**Fig. 3. Image taken by SEI on June 4, 2023, indicating beam pin (yellow arrow).**

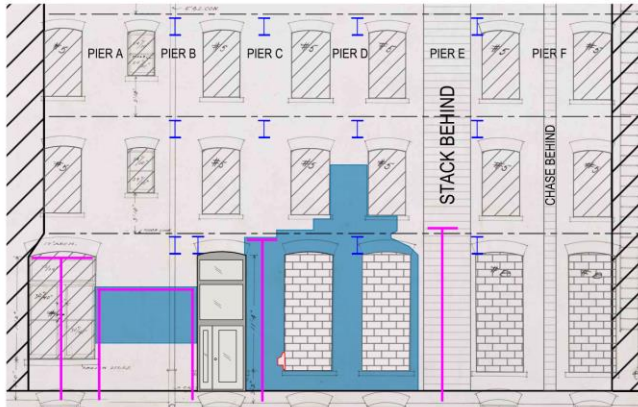
**CONDITION 15 MINUTES PRIOR TO COLLAPSE  
TEMPORARY STRUTS IN PLACE, PORTIONS OF BRICK REMOVED**

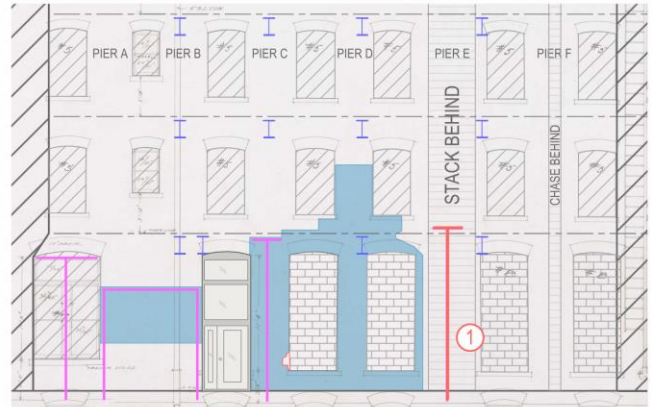
**CONDITION 10 MINUTES PRIOR TO COLLAPSE  
SOUTHERNMOST STRUT STARTS TO FLEX - TAKING ADDITIONAL LOAD**

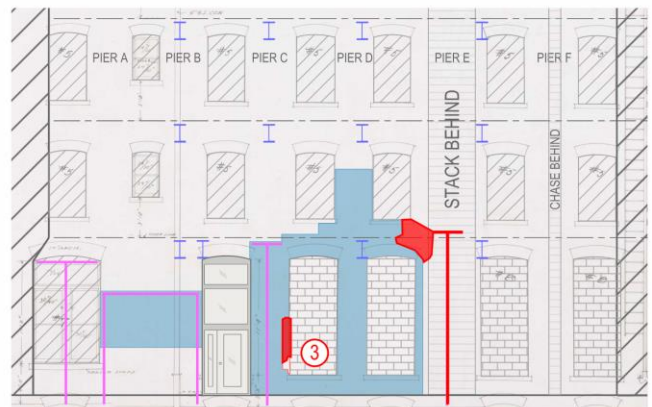
**56 SECONDS PRIOR TO COLLAPSE  
BRICK AT SOUTH END OF PIER C DETACHES**

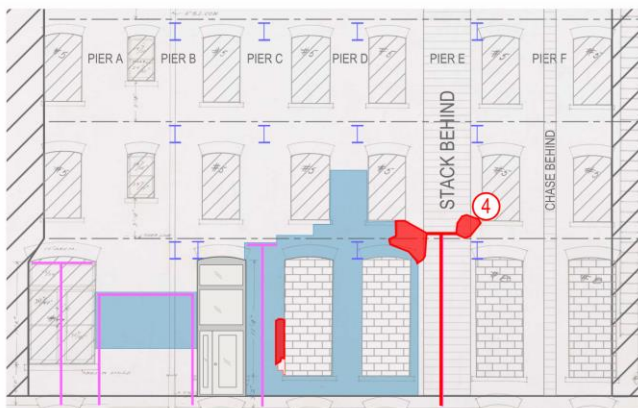
**45 SECONDS PRIOR TO COLLAPSE  
BRICK PIECE AT SOUTH END OF PIER E ADJACENT TO STRUT DETACHES**

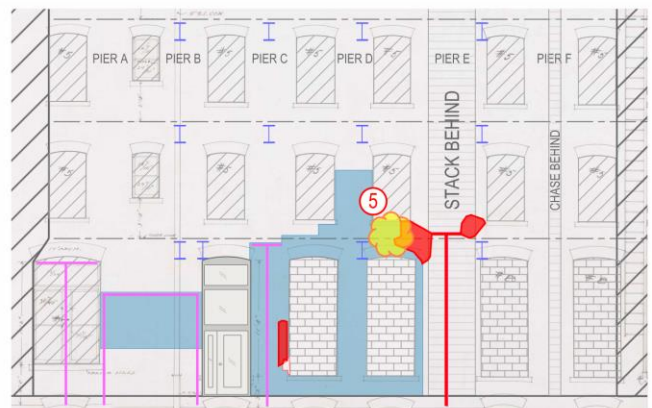
**2 SECONDS PRIOR TO COLLAPSE  
COLLAPSE APPEARS TO INITIATE BELOW WINDOW SOUTH OF PIER D**

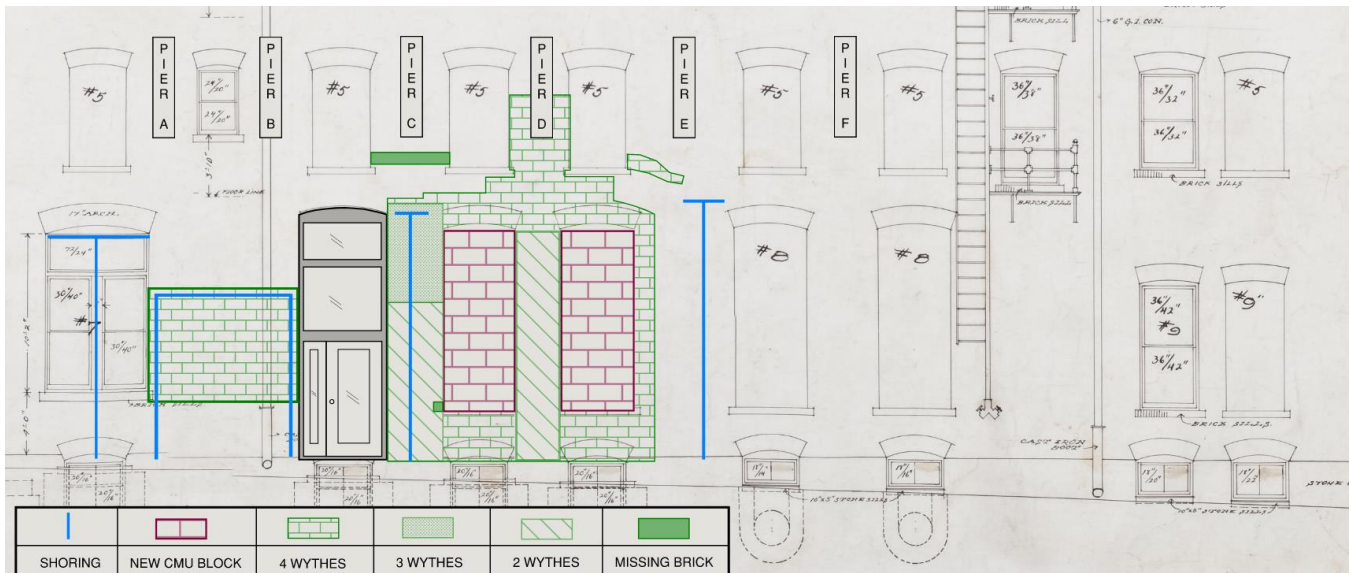
Based on a review of security camera footage, no further work was performed within the area displayed in **Fig. 16** after May 27, 2023. **Fig. 17** delineates the extent of the brick removal as evidenced in the May 27, 2023, photographs, and understood to be unchanged prior to the collapse at approximately 5:00 pm on May 28, 2023.

**Fig. 17.** West elevation markup indicating assumed amounts of remaining brick after brick removal prior to collapse on May 28, 2023.

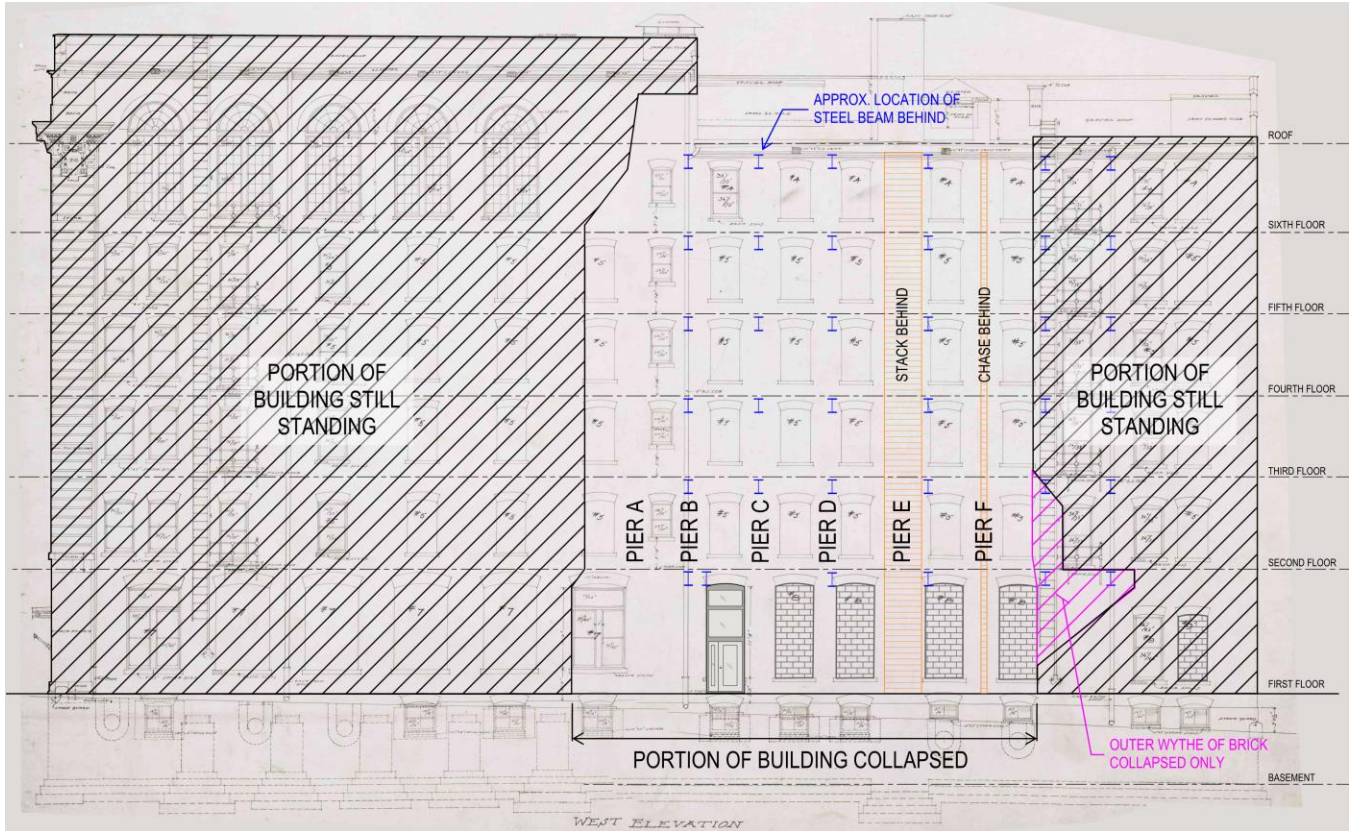
**Fig. 18. West elevation view indicating the portion of the elevation that collapsed on May 28, 2023.**

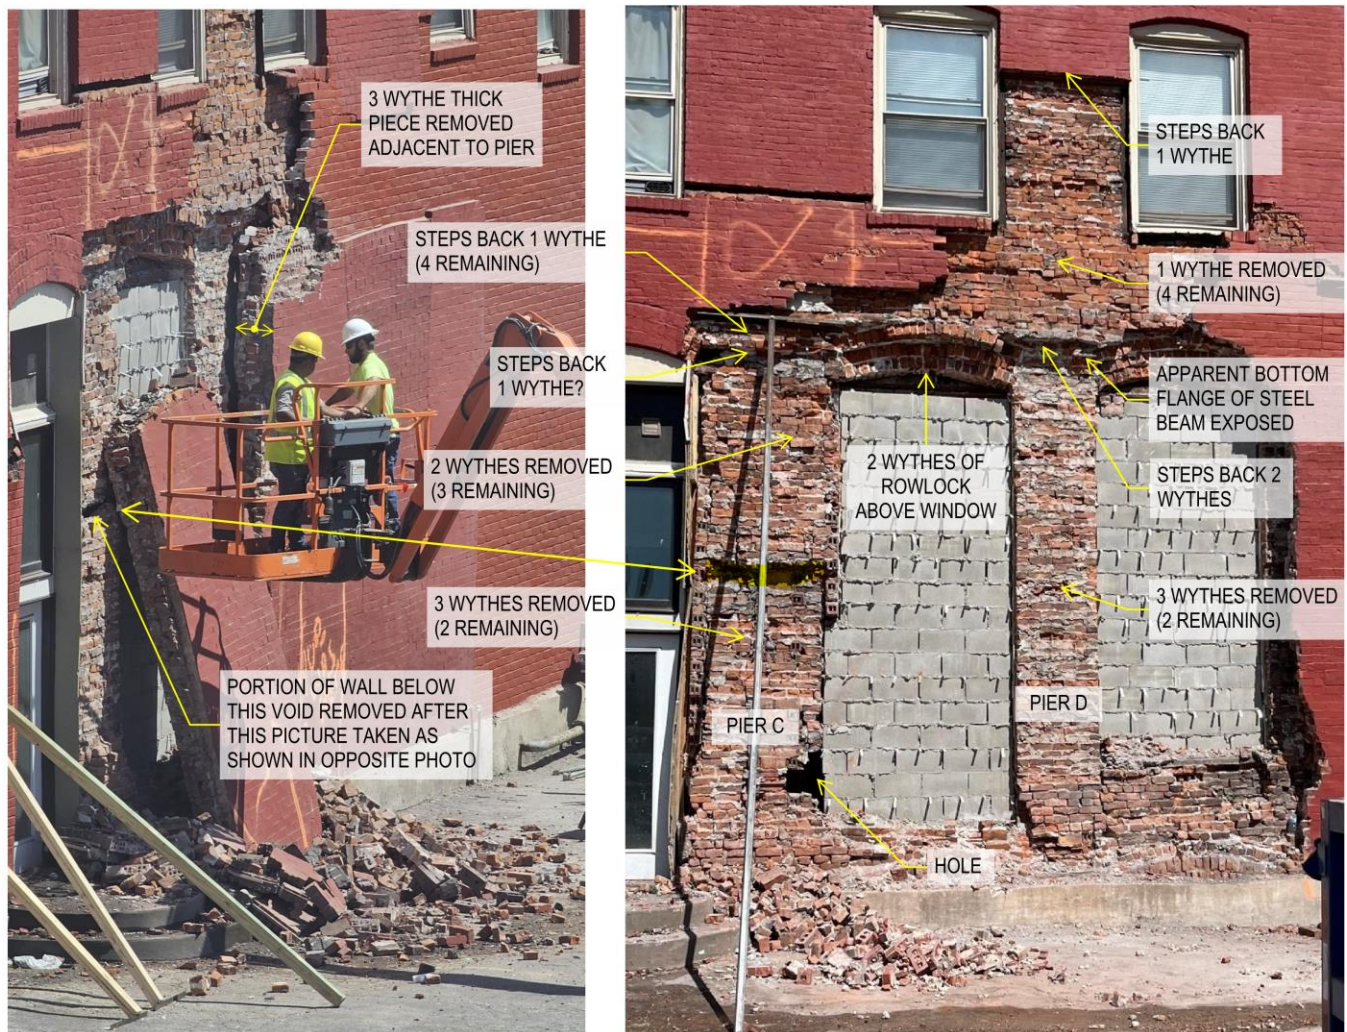
The analysis focuses on Piers C and D due to the removal of masonry, photographic evidence of wall distress, and proximity of these piers to the location of failure initiation indicated on the security video. No calculations were performed for Piers E and F due to the unknown composition of the wall in those locations subsequent to the various masonry repair projects.

**Fig. 23. Basis of pre-collapse condition utilized for analysis of Piers C and D.**

Calculations by WBG and SEI indicate that the removal of the outer wythes of brick demonstrably compromised the wall’s ability to resist the loads on it at the time of collapse, particularly at Piers C and D, such that collapse was imminent. Pier D at the 1<sup>st</sup> floor was the most significantly overstressed (where this tall and narrow pier appears to have been reduced to only two wythes thick (see Fig. 23). Pier D at the 2<sup>nd</sup> floor was also marginally compromised. Pier C was similarly overstressed (note that the wall at this location also featured voids that would have significantly reduced the capacity beyond that assumed in this analysis).

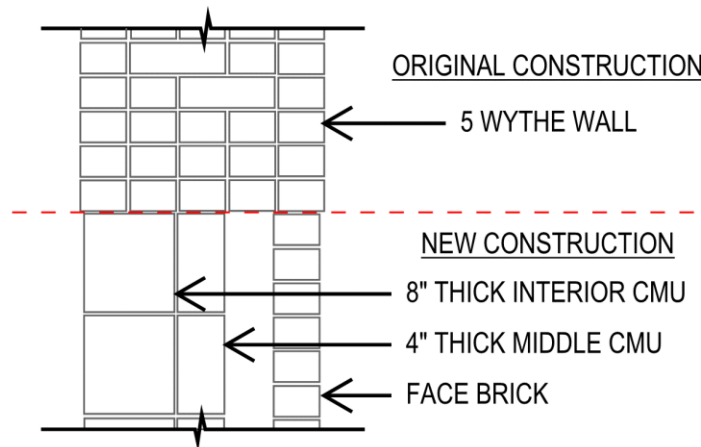
The lack of composite connection resulted in the single exterior wythe of brick masonry veneer of this configuration supporting approximately a third of the load from the composite masonry wall above, with the remaining two-thirds supported by the 12 in. of hollow CMU. This condition yields a bearing stress increase of approximately 67%, compared to a single wythe of the original construction above. The result of this increase in bearing was the visible large lateral displacement (bowing) of the brick masonry at the outer wythe.

Further, since the new CMU wall construction did not provide continuous bearing support for all 5 wythes of the masonry bearing wall above, and left one of the intermediate wythes vastly unsupported (**Photograph 18** and **Photograph 19**) some of the unsupported brick masonry above became disengaged, and the loose brick fell and collected at the base of the first-floor wall cavity between the CMU backup and the outer brick veneer. This condition exacerbated the wall distress by exerting additional forces on the brick veneer. The accumulation of loose masonry was reported by SSE in their Addendum letter dated February 28, 2023 (**Photograph 21**).

**Fig. 25. Configuration of wall resulting from early 2023 repair project**

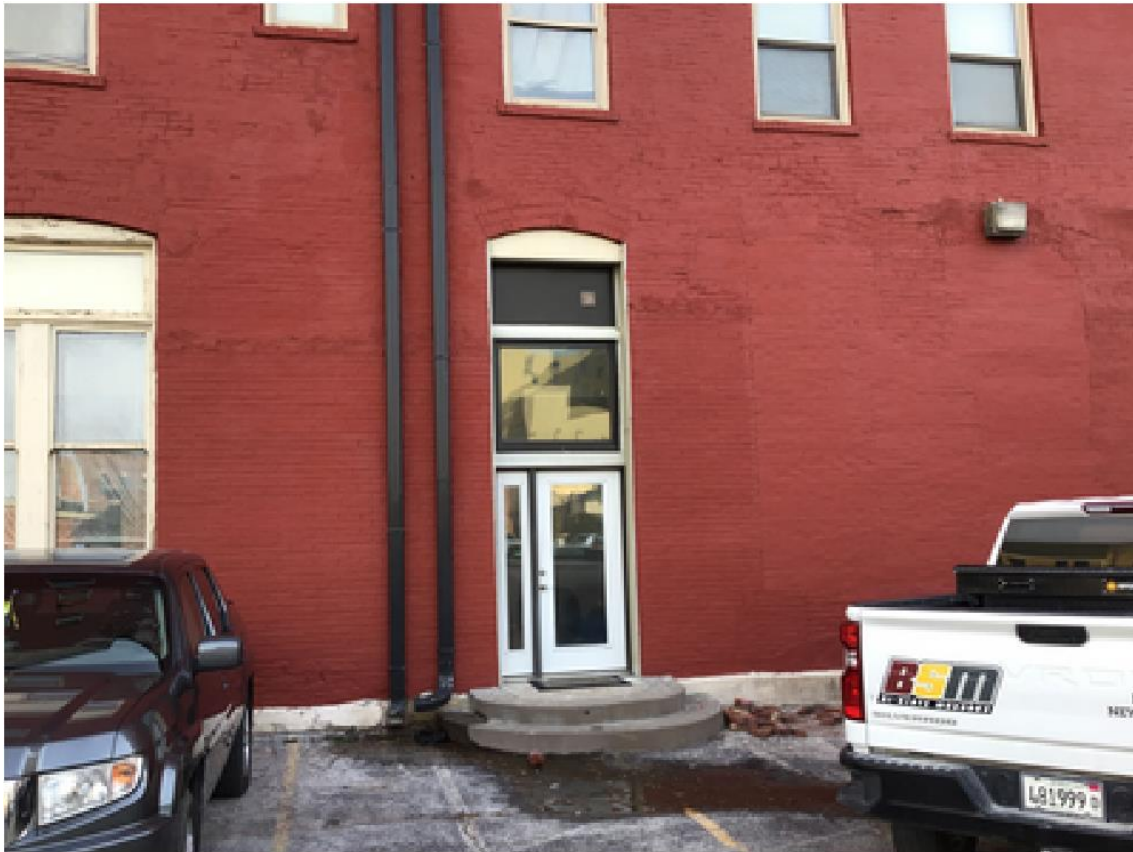
Fig. 31. Image of the west elevation adjacent to Unit 105 door taken on November 1, 2021 (Ref: City Report, Task ID: 21-64101).

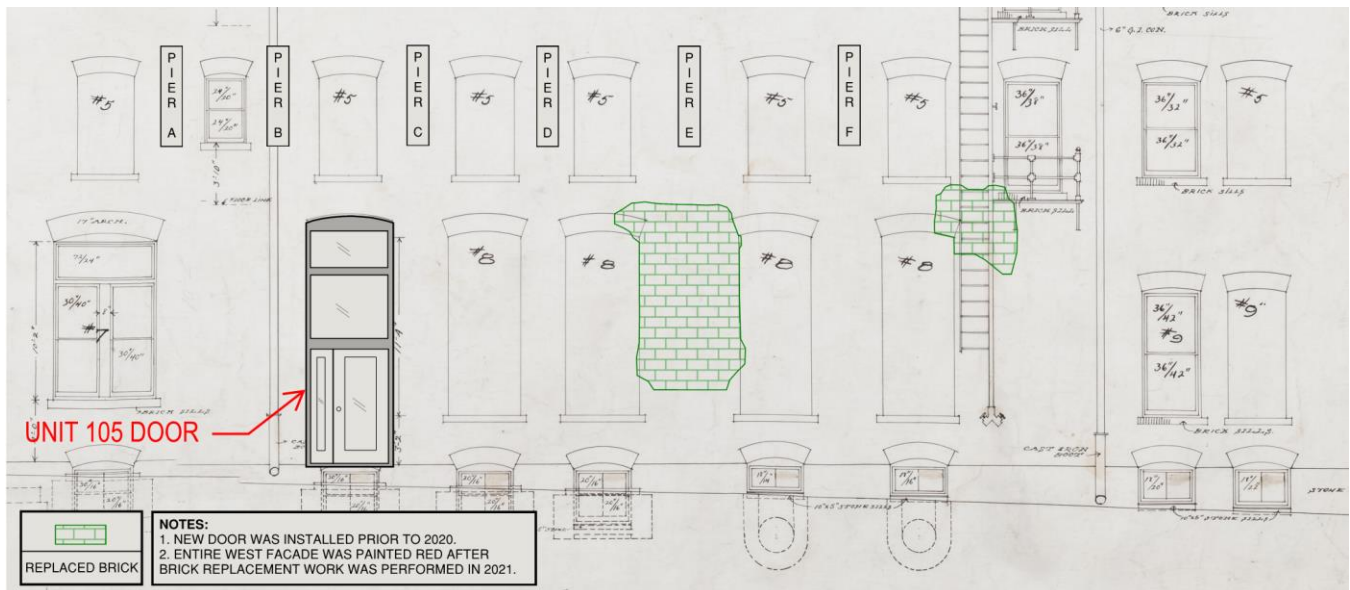
Fig. 32. West elevation markup indicating areas of repair completed in 2021.

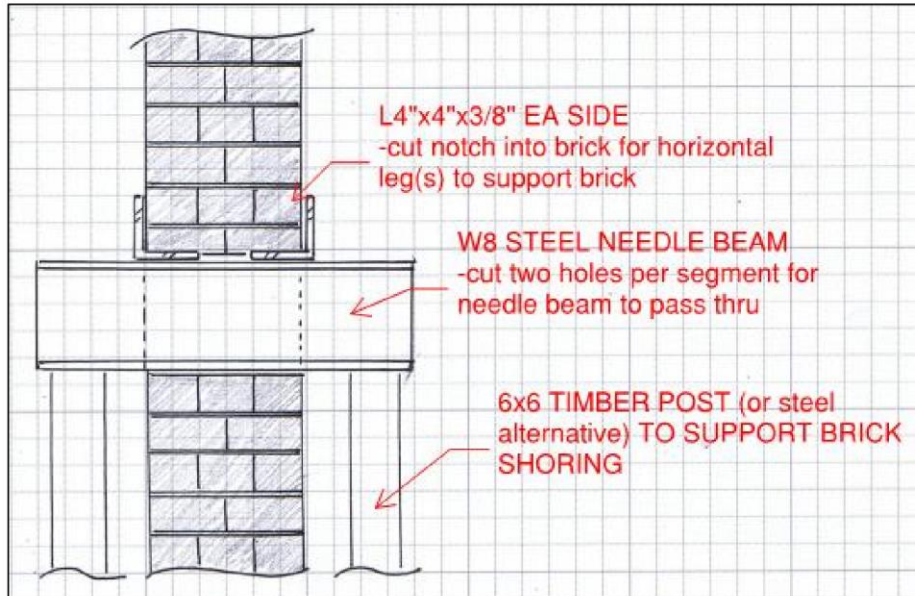
**Figure 8 – Brick Wall Shoring Detail**

Further, SSE's "Figure 8" contained within the February 8, 2023 (**Appendix A: Fig. 36**), letter delineates a 3-wythe masonry wall, instead of the 5-wythe wall that existed. Although no scale is indicated, the dimensions assigned to the shoring elements contained in the drawing suggest a total wall thickness of approximately 12 in. and the original SSE replacement design only specified a single wythe of CMU replacement to support the 5-wythe wall.

Figure 8 of SSE's February 8, 2023 letter (included as **Fig. 36** in this report) shows a section through the wall. The wall was drawn as 3 wythes thick (rather than the 5 indicated on the original drawings), with steel angles supporting only the innermost and outermost wythes.

**Fig. 36. Figure 8 from SSE's February 8, 2023 showing needle beams and angles.**

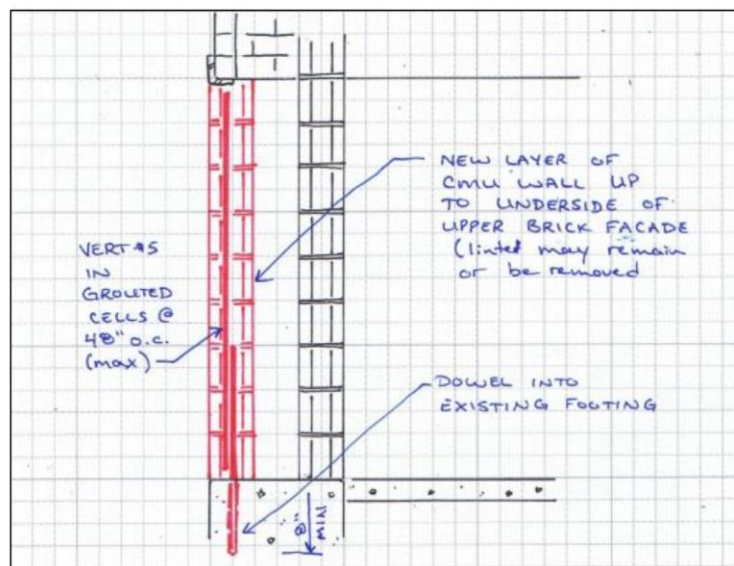
Figure 3 – New CMU Wall

Diagrams were attached to the end of the report indicating how to execute this repair, but no sketch was produced indicating the extent of the required repairs (see **Fig. 38**). The repairs noted the use of a steel lintel to secure the upper façade however no size was provided for the lintel and no detail was provided for how to support it at each end.

**Fig. 38. SSE repair addendum sketch from February 28, 2023 letter.**

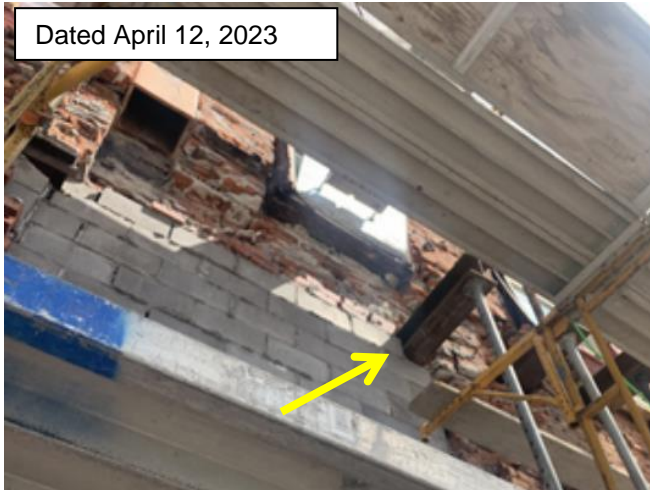
Photograph indicates repairs underway with use of needling beams evident.

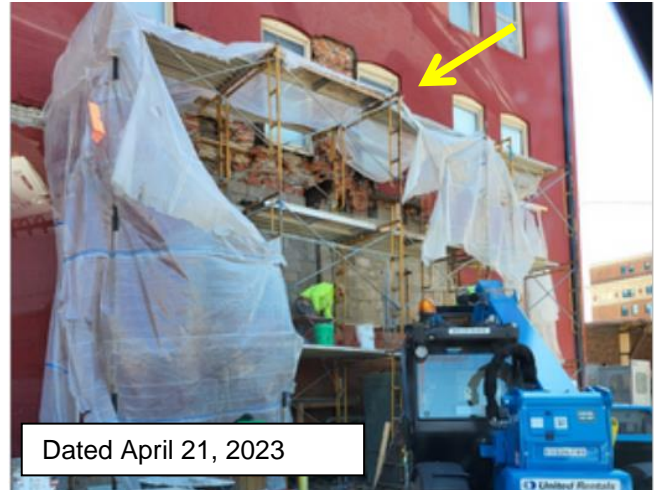
Overall view of repairs underway at southern end of west façade.

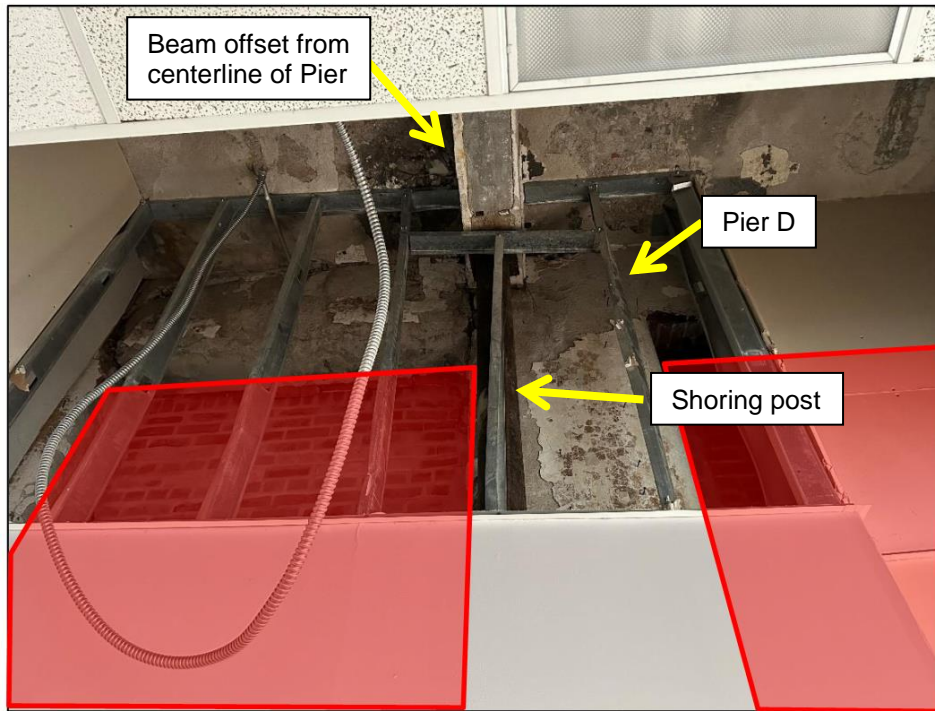
Photo 2 – Window Openings to Infill

SSE also included an image of the interior of the building at the location of these window openings. WBG and SEI have previously identified this Pier as “Pier D” in **Section 4** of this report. The image appears to indicate a steel shoring post contained within the interior finishes. Note this shoring post and the structural beam it is supporting , are located eccentric to the centerline of the Pier. See **Fig. 42**.

Fig. 42. View of the interior of the building from SSE’s May 24, 2023 letter. Red annotation by SSE. Yellow arrows by WBG and SEI.

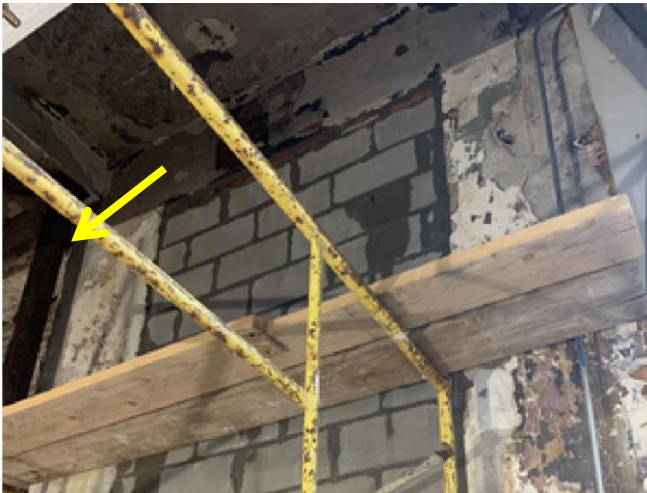
Photograph indicates inside of building with CMU installed inside window opening. Note shore previously identified at Pier D (yellow arrow).

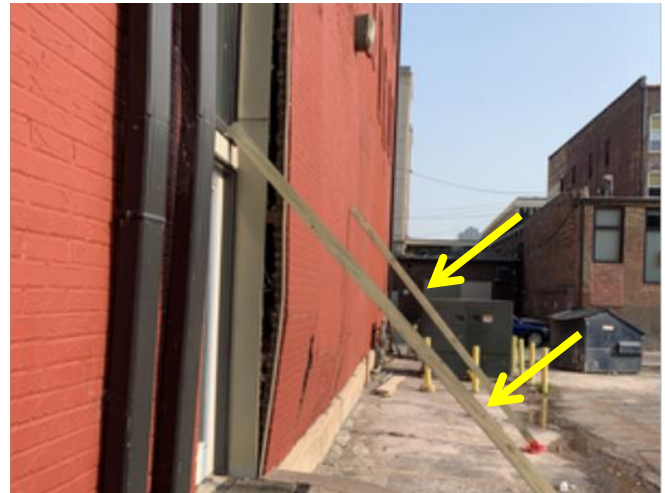
Photograph indicates area of bowing brick south of doorway. Note “shores” in place that do not appear to conform with SSE’s design.

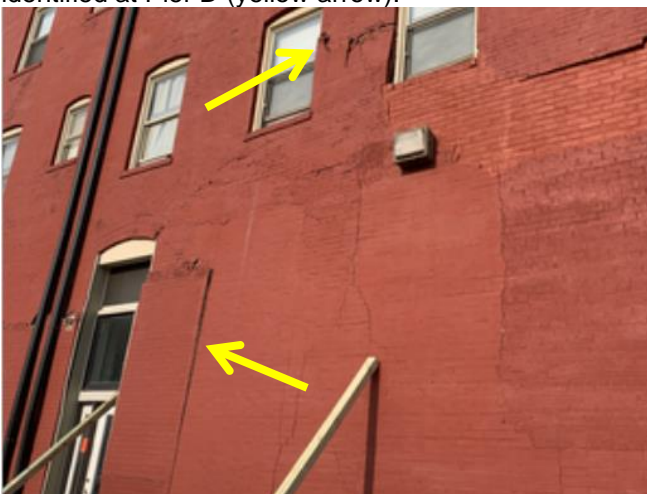
Overall view of portion of west elevation south of door. Note numerous areas of deterioration to wall.

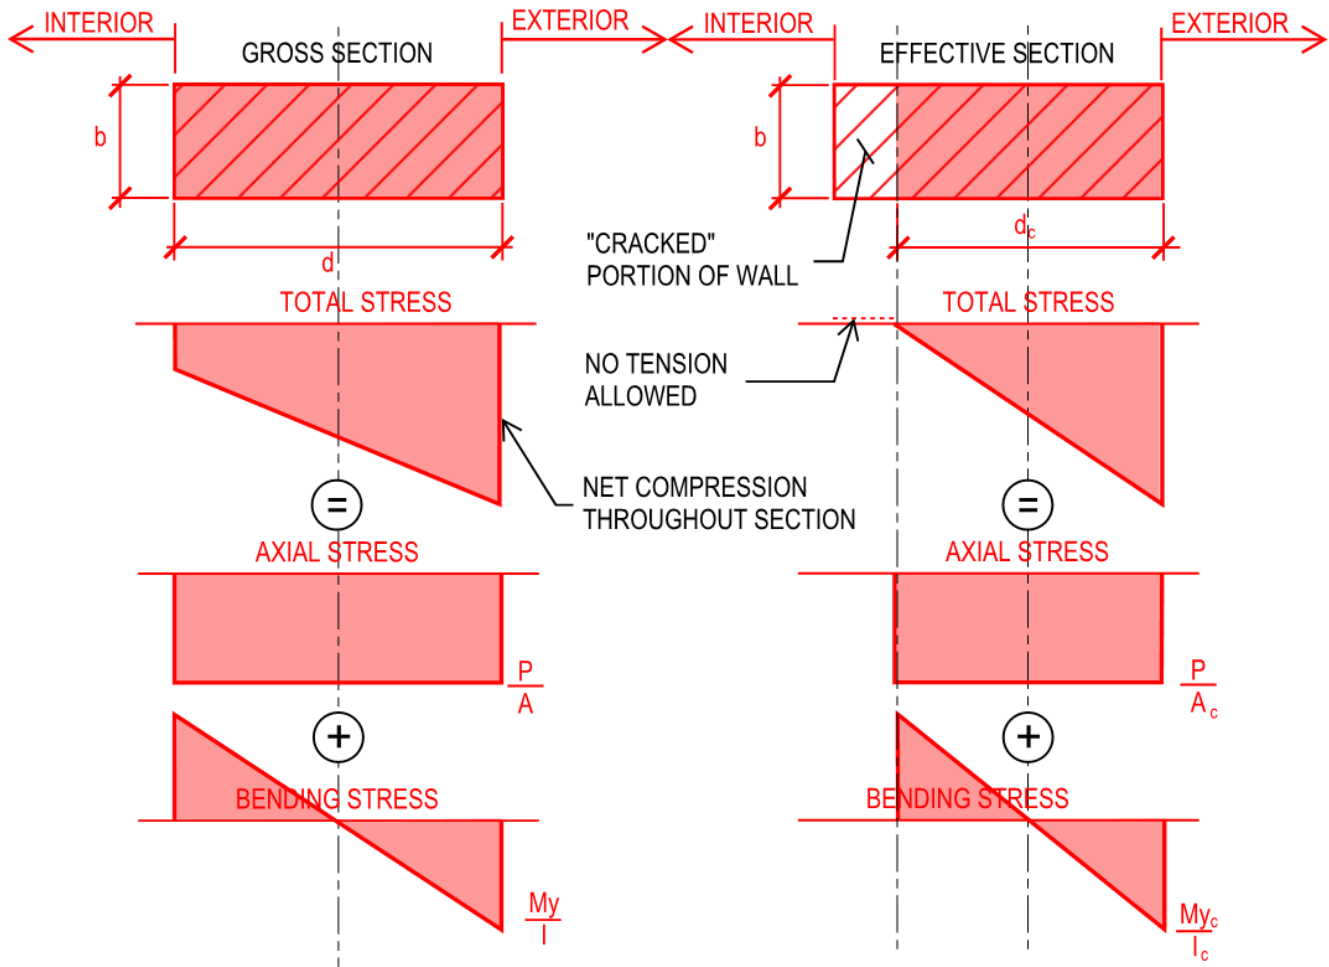
Fig. 45. Assumed stress distribution in wall section

Since the code equations are derived for design purposes to produce safe structures with significant factors of safety (typically a factor of safety of 4), first principles of stress distribution have been used to determine the actual capacity of the wall more accurately at the time of collapse, see **Fig. 45**.

When the axial force is applied at an eccentricity beyond the “kern” of the member (outside the middle third of the section), the member goes into net tension on its outer fibers. Based on the observed condition of the wall at the time of collapse, the known limited tensile capacity of brick masonry, as well as the age of the structure, it has been assumed that no tension is allowed to develop in the section. Thus, a reduced “effective” section must be considered for stress balancing for load applied at an eccentricity beyond the kern of the member. The following equations and derivations form the basis for the analysis of the wall.

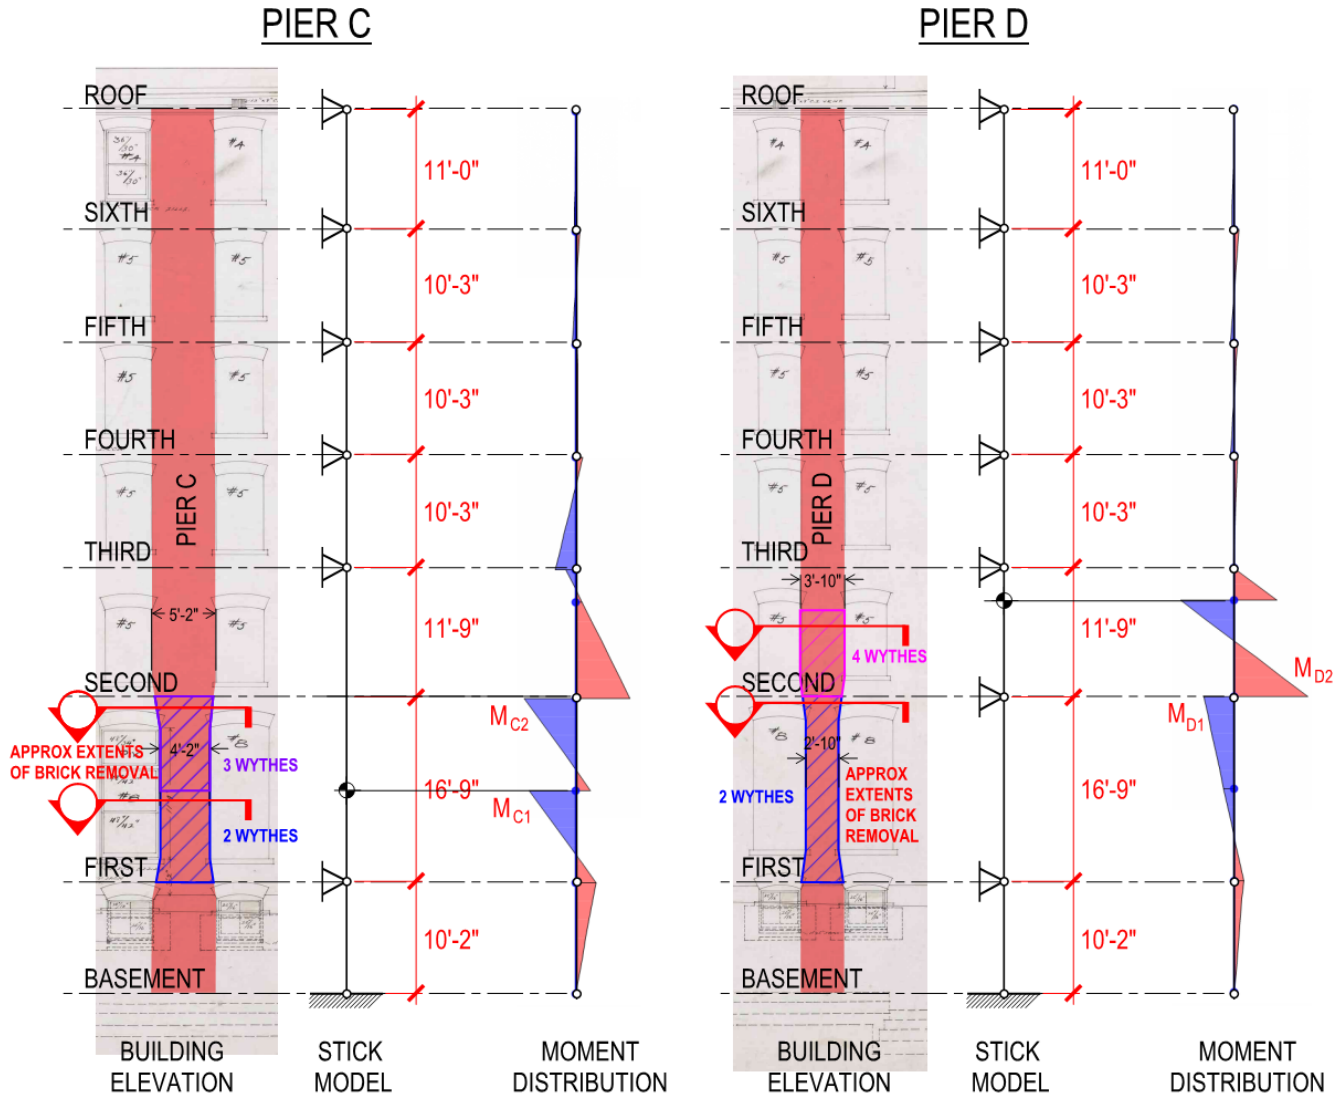
Fig. 46. Wall Pier Moment Distribution Analysis

The Euler Buckling equation ( $P_e$ ) provided in the code assumes the most conservative condition of a fully cantilevered wall (fixed at the base, with the top of the column free to translate – i.e., a ‘flagpole’ with a load,  $P$ , applied at an eccentricity,  $e$ ) with uniform moment and zero allowable tension. For the purposes of this assessment see **Fig. 46** the actual moment ( $M$ ) was calculated based on the actual force distribution and assumed restraint conditions of each pier.

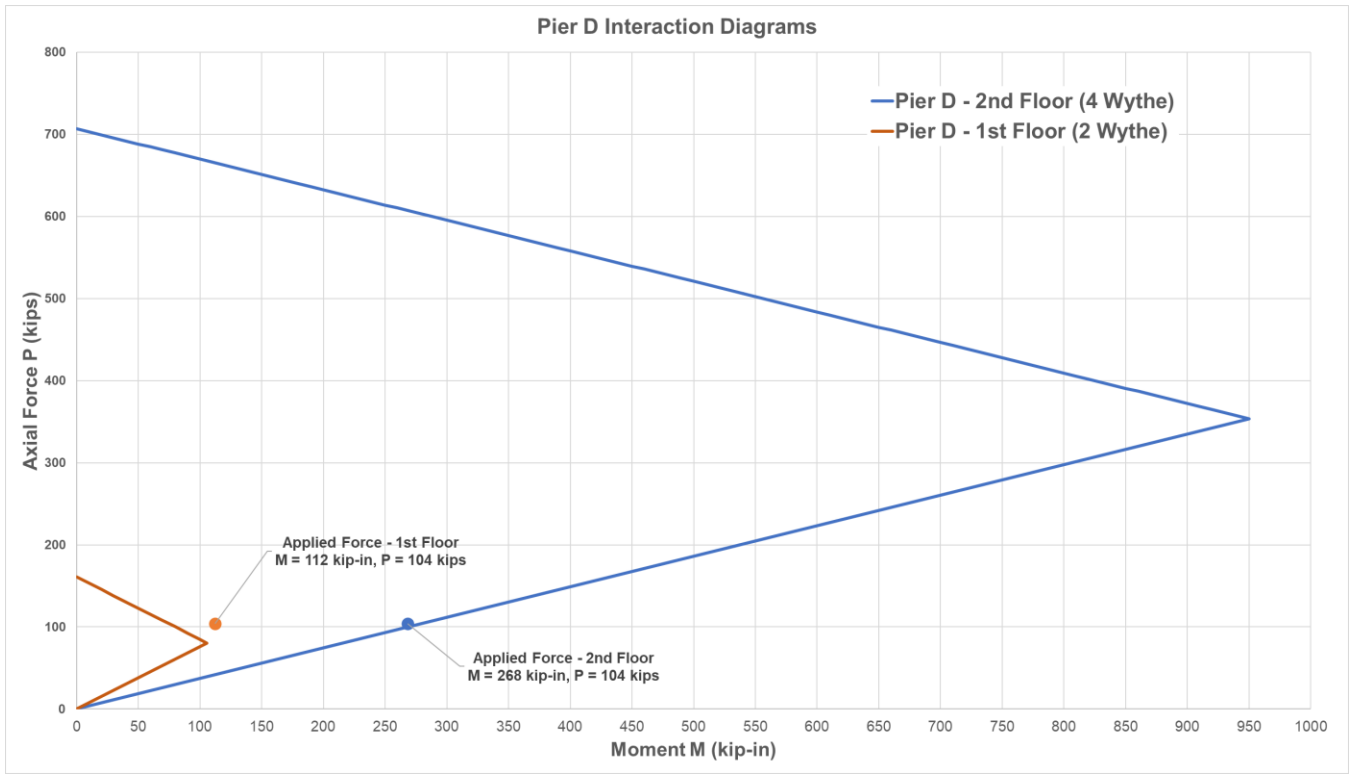
Fig. 47. Interaction Diagrams for Pier D.

Based on the above, an “Interaction Diagram” can be plotted for each Pier. This diagram plots axial load (P) against moment (M) for each of the Pier conditions. As the moment increases, and portions of the wall are put into tension, the wall is assumed to “crack” and the effective section is therefore reduced. This is only slightly negated by the slight reduction in effective eccentricity of the load (which has been neglected in this analysis). The actual calculated applied axial force and moment can then be plotted on the graph. If this falls outside the line of the Interaction Diagram, the member section capacity has been exceeded and the Pier is predicted to fail.

Pier	Floor	Axial Load	Moment
Pier D	2-3	104 kips	268 kip-in ( $M_{D2}$ )
Pier D	1-2	104 kips	112 kip-in ( $M_{D1}$ )
Pier C	Upper 1-2	93 kips	186 kip-in ( $M_{C2}$ )
Pier C	Lower 1-2	99 kips	160 kip-in ( $M_{C1}$ )

This analysis indicates that the wall was very close to or beyond its theoretical ultimate capacity at the time of its collapse at both Piers C and D. It should be noted that while this analysis represents an upper bound on the assumed capacity of the wall (with the assumptions summarized at the start of this section of the report), some idealized behavior has been assumed in order to perform these calculations at this time.

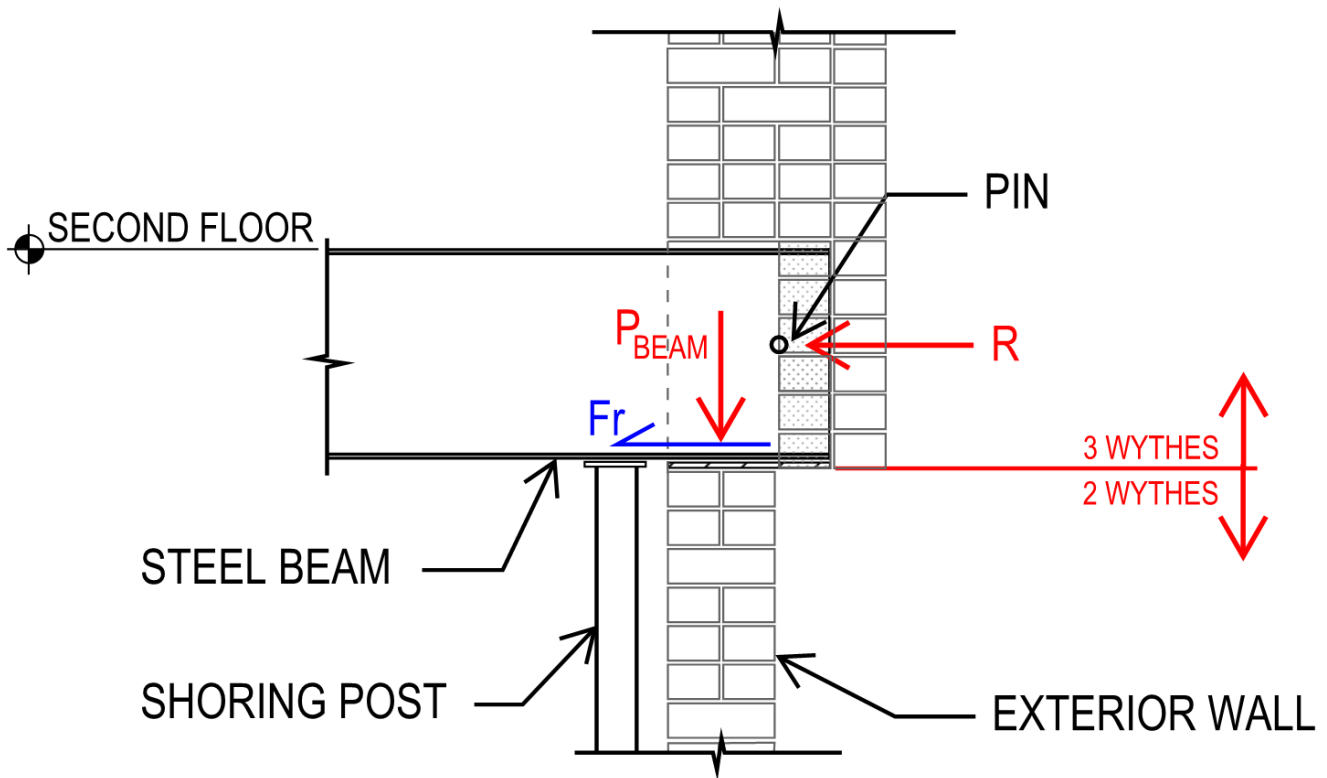
Fig. 49. Reaction at beam connection to Pier D at the second floor.

In order to provide stability to the Pier(s), axial forces would be transferred from the exterior wall to the interior beam framing and ultimately to the overall lateral stability system for the building. These forces would have been significantly increased as a result of the bending moment introduced as a result of the eccentricity caused by the removal of the outer wythes of brick. For example, at the second floor connection to Pier D, the wall would exert an outward force that would then be translated to tension in the beam. The mechanism to transfer this load would be through friction at the beam-to-wall interface as well as a contribution from the pin embedded within the wall (included in Fig. 3 earlier in the report). Due to removal of the outer wythes of brick the effectiveness of the pin would have been compromised and due to the noted location of the shoring post at Pier D (reducing the load transferred from the beam to the wall), the friction load transfer between the beam and the wall may have also been reduced. The combination of these effects would be significant enough to have also contributed to the collapse. The effect of the beam pulling or pushing through the wall would effectively create localized distress in the wall which would further weaken the wall.

Many factors regarding the condition of the west wall described elsewhere in this report would also reduce the capacity of the wall considerably. Therefore, the above listed results are a conservative “best case” scenario regarding capacities and performance of the wall components.

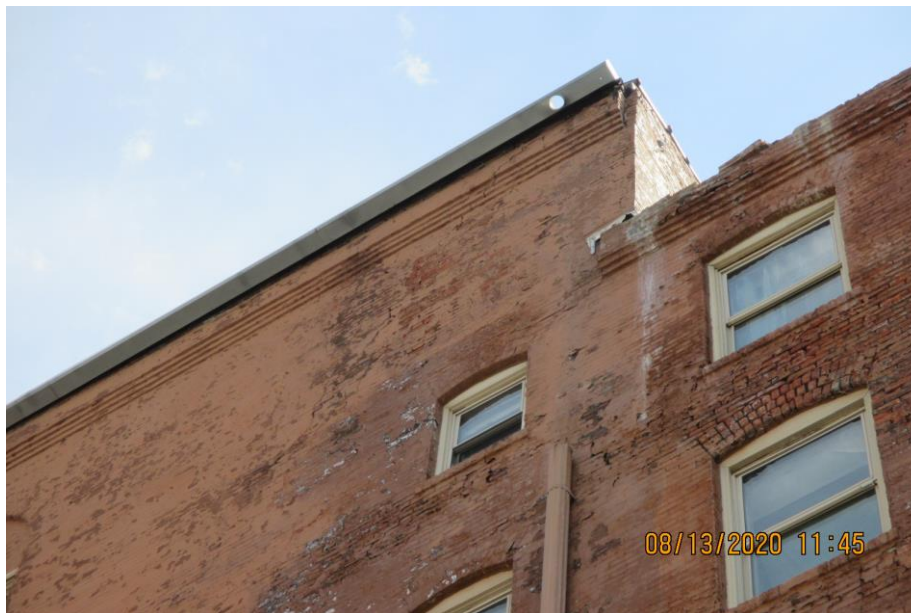
**Photograph 2: August 2020 image of west elevation from City report.  
Note open mortar joints and masonry distress.**

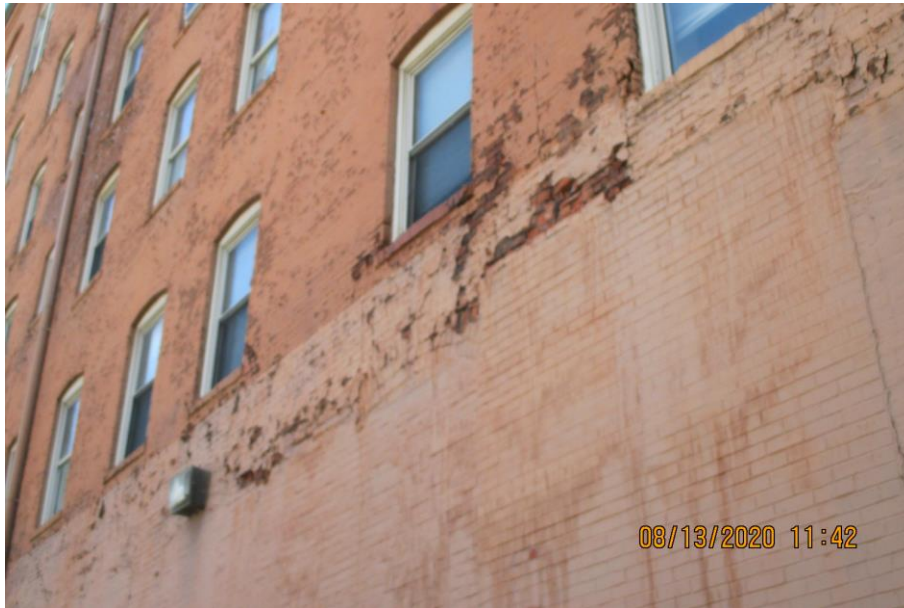
**Photograph 3: August 2020 image of west elevation from City report.**  
Note open mortar joints and masonry distress.

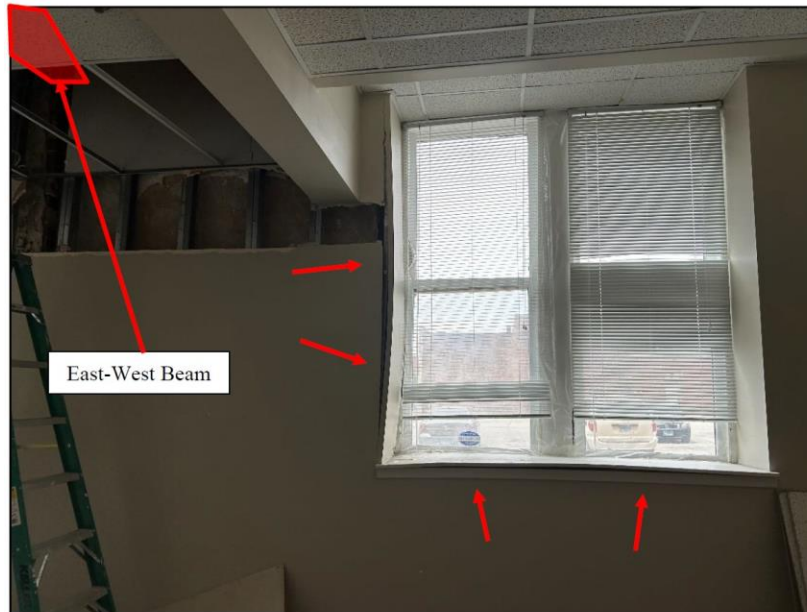
**Photograph 15: Image contained in May 24, 2023 SSE letter.**

Note deformation at window jamb and sill, indicative of exterior wall movement.

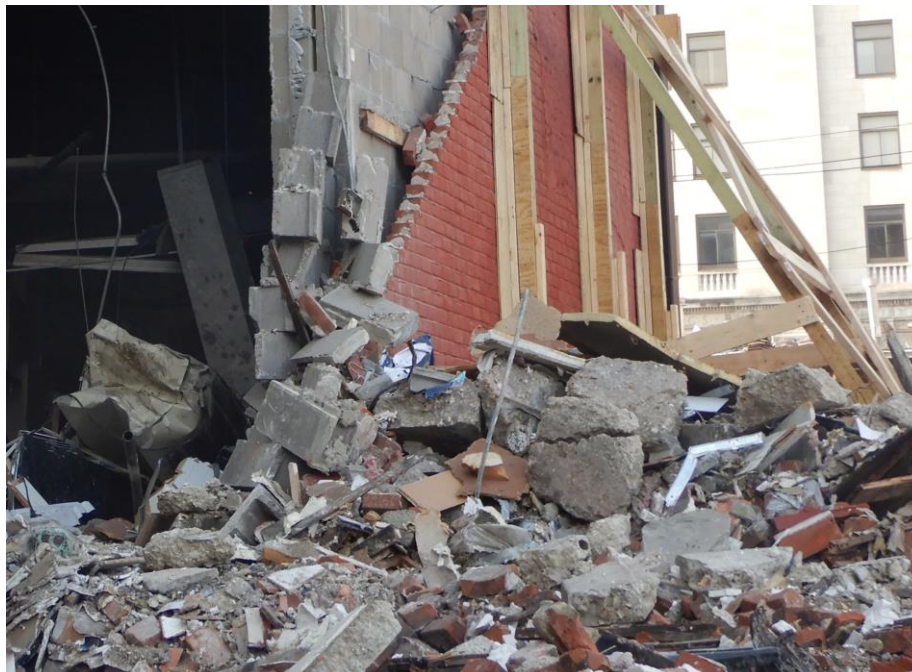
**Photograph 16: Post-collapse photo of west elevation wall.**

Note lack of reinforcing steel or grouted cells in CMU wall component debris.

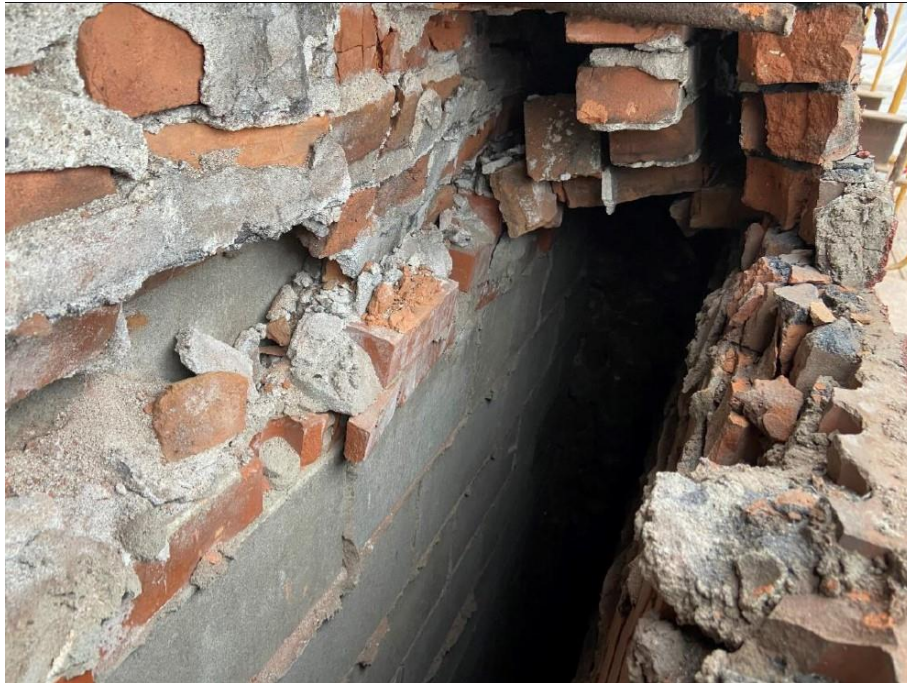
**Photograph 21: Image from SSE February 28 Addendum letter.**

Note cavity between CMU wall and exterior wythes, and unsupported upper wythes of masonry.

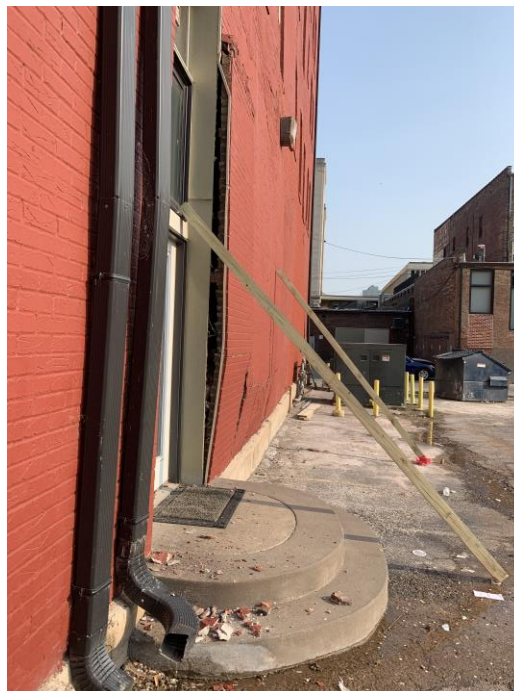
**Photograph 22: May 25, 2023 image from City file 32-30329.**

Note bowing masonry wall and inadequate shoring attempt.

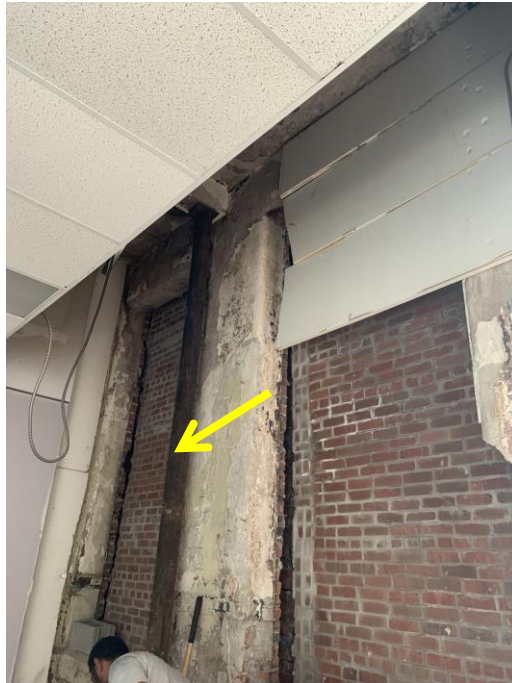
There were also numerous indications of ongoing deterioration of the original structural members observed during evaluation of the Building and evaluation of photographic records. Numerous photographs indicate the presence of supplemental steel shoring posts at the interior of the subject Building (**Photograph 31 and Photograph 32**). **Photograph 32** (extracted from SSE’s February 2, 2022, letter) exhibits a supplemental steel beam as well. It is unclear exactly when and why these components were installed at the Building; however, these types of components would generally be required to mitigate structural deficiencies in the building. Due to the location of these elements at the exterior wall of the building, it is probable that water-induced corrosion weakened the existing structural members and/or their connections, and thus required reinforcement.

**Photograph 31: Image from City file 23-30329.**  
Note previously installed supplemental steel post.

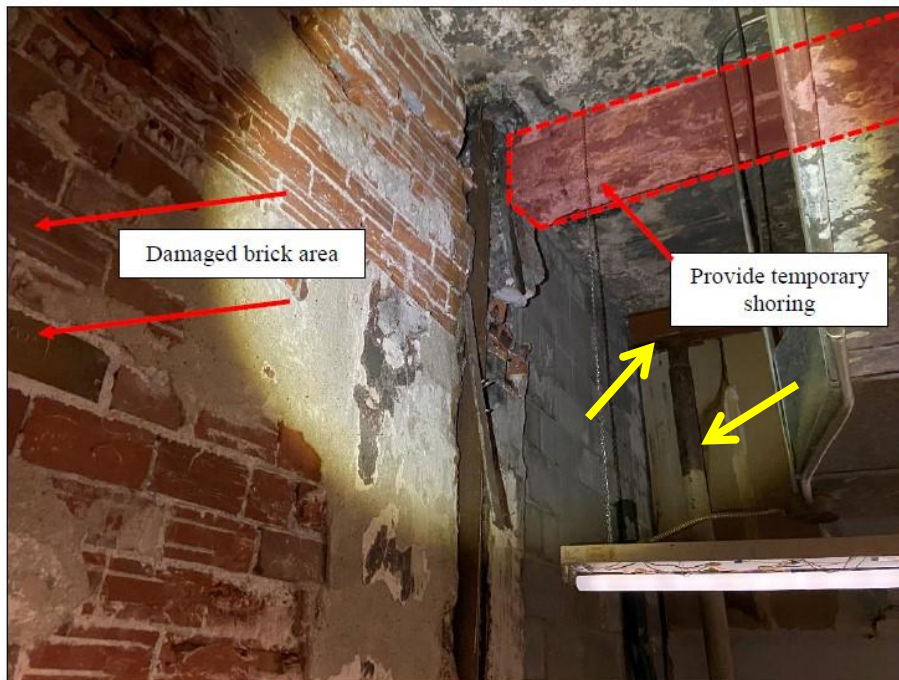
**Photograph 32: Image and annotation from SSE February 2, 2023 letter.**  
Yellow annotation (by WBG/SEI) denotes supplemental steel post and modern steel beam.
