**324 N. Main Street, Davenport IA – Partial Collapse  
Preliminary Investigative Report**

LF232566 / WBG202306  
August 15, 2023

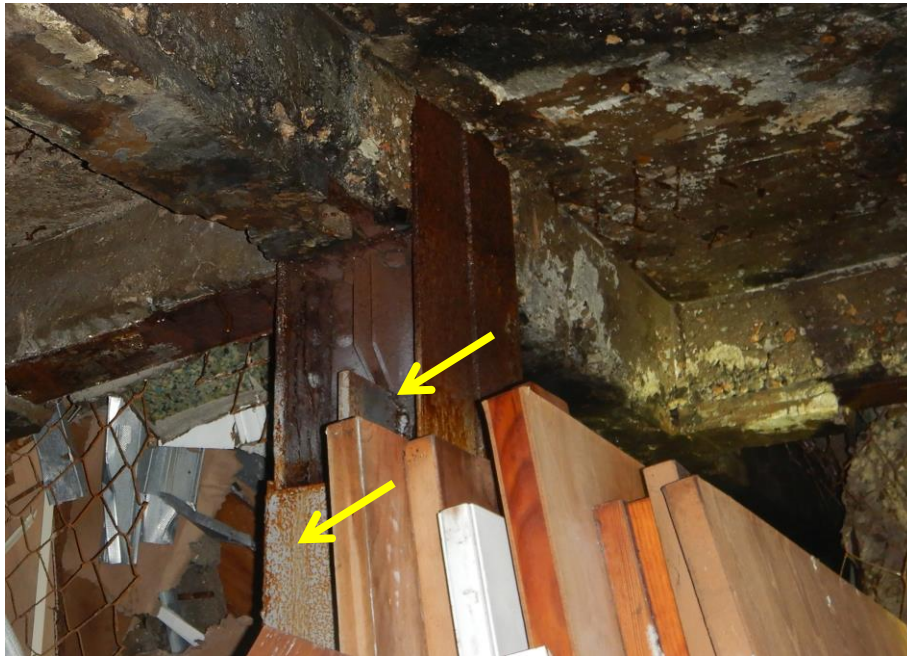
Lastly, several basement columns exhibited reinforcement at the connection to the beams framing into said column (**Photograph 33 and Photograph 34**). The column cover plating and supplemental steel angles suggest a deficiency at this connection location. It is unknown if this condition was due to ongoing water infiltration and resultant corrosion, or some other overstress condition.

**Photograph 33:** Image and annotation by WBG/SEI of basement column.  
Note cover plate and vertical stiffener.

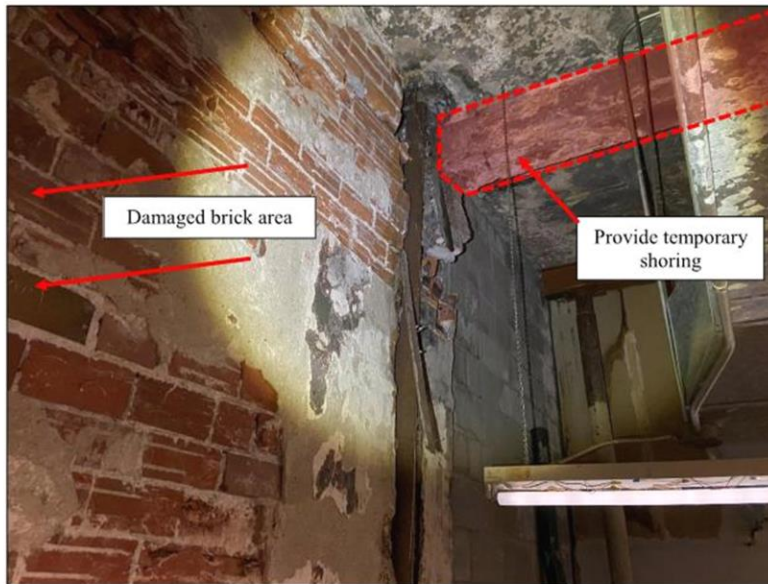
Photo 2 – Second Beam to Support

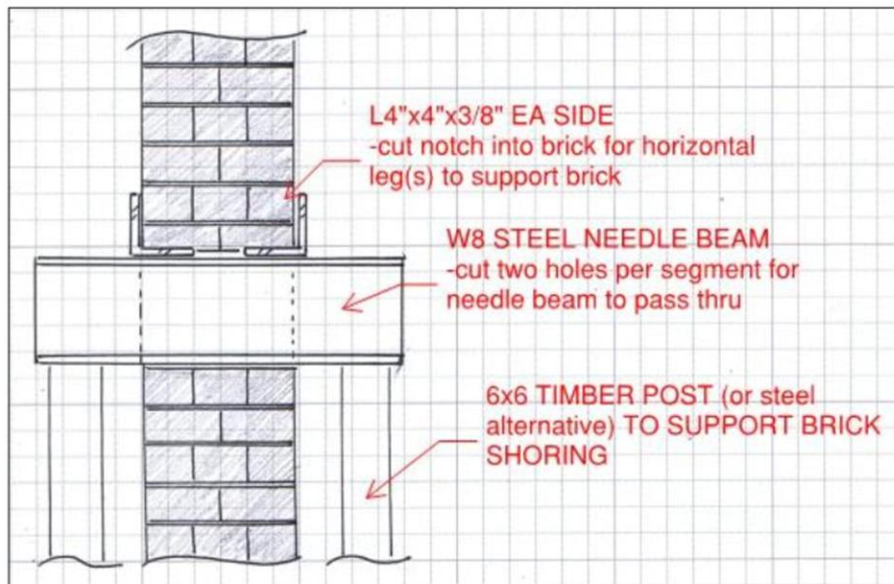
Figure 8 – Brick Wall Shoring Detail

Figure 8 of SSE's February 8, 2023 letter (included as **Fig. 36** in this report) shows a section through the wall. The wall was drawn as 3 wythes thick (rather than the 5 indicated on the original drawings), with steel angles supporting only the innermost and outermost wythes.

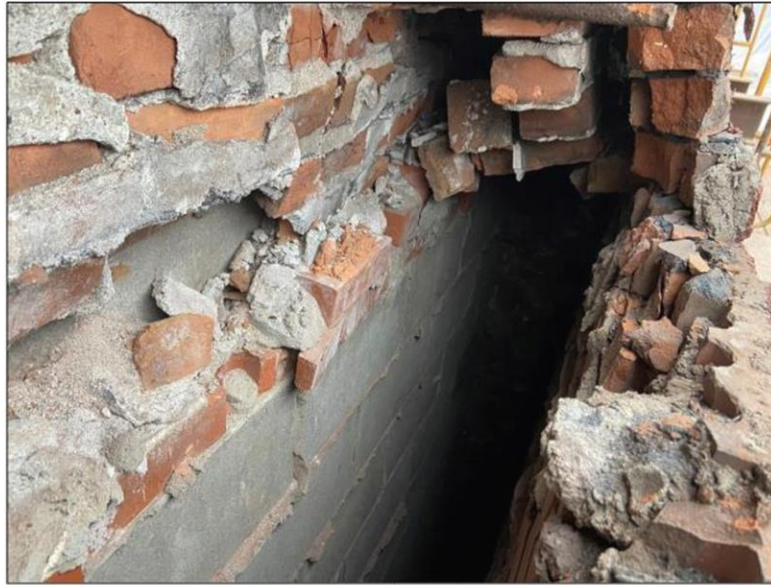
Photo 1 – Void between CMU and Clay Brick Façade

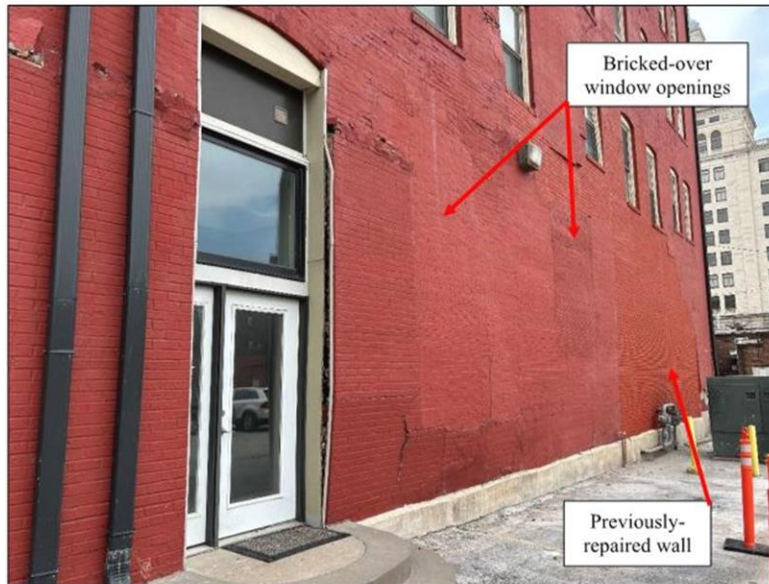
A follow-up site visit was performed at the property above on May 23<sup>rd</sup>. On the west face of the building, there are several large patches of clay brick façade which are separating from the substrate. These large patches appear ready to fall imminently, which may create a safety hazard to cars or passersby. The owner has already blocked off the area with cones and has begun removing drywall from the inside of the wall to get a view of what might be happening.

Photo 1 – Clay Brick Façade pulling away from Substrate

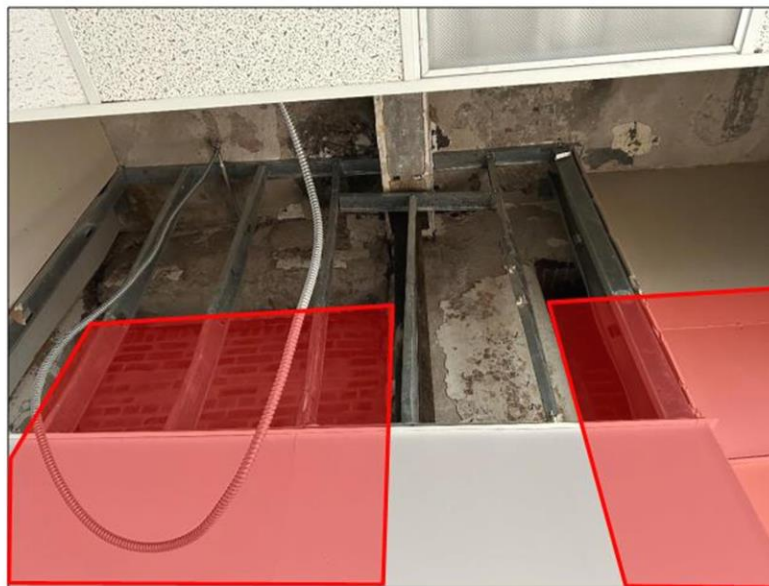
Photo 2 – Window Openings to Infill

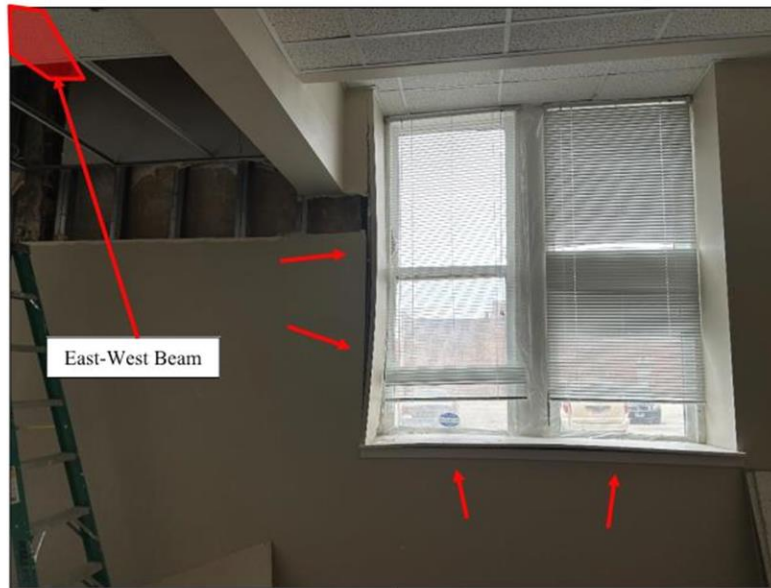
Photo 3 – Excessive Downward Pressure on Finishes

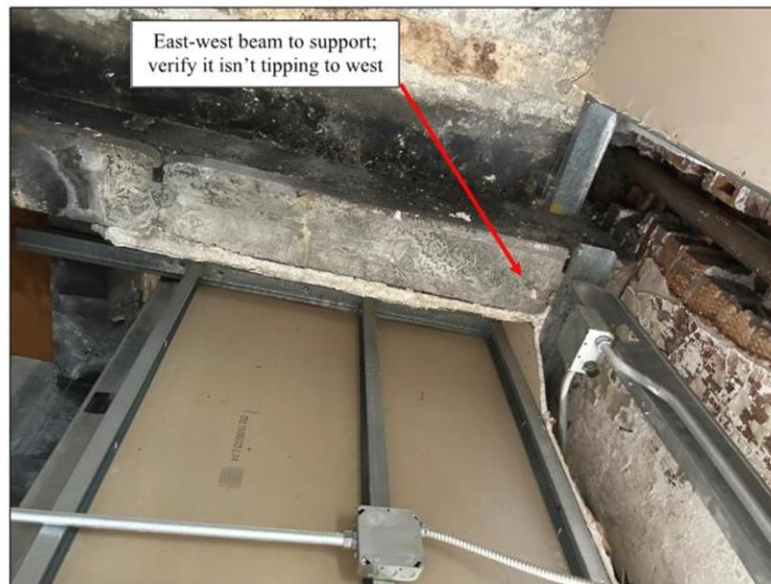
Photo 4 – Existing Beam to Support
