## An Explosive Decompression Accident

On 5 November 1983, an accident resulting in the sudden decompression of four divers from a pressure of 9 atm to 1 atm occurred on board the Norwegian oil rig Byford Dolphin in the North Sea.

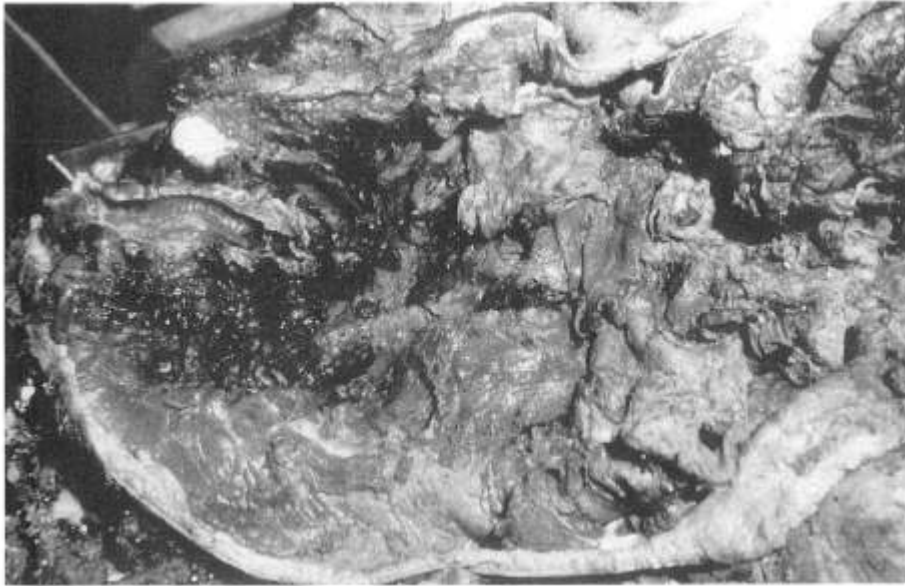
**FIG. 9.** The opened thoracoabdominal cavities of diver 4. Trachea to the left. Remains of the small bowel, otherwise empty.

below the hip joint. The pelvis itself had been divided into three parts. To one of these parts, a small segment of the small bowel was attached. The penis was present, but invaginated. The soft tissues of the abdomen and the back had been cut straight through at a level about midway between the umbilicus and the pelvis, and thus had been separated from the pelvis. These soft tissues formed an empty sack. From above, one could look down through the larynx. All the thoracic and abdominal organs had been expelled, except the trachea and a fragment of the small bowel (Fig. 9). Even the spinal column (Fig. 10) and most of the ribs had been expelled. The liver had been found somewhere on the deck. It was complete, as if dissected out of the body.

undoubtedly mutilated when he was shot out through the small opening left by the jammed chamber door. However, the expulsion of all internal organs from the thoracoabdominal "sack," including the spinal column and the ribs, suggests that he also must have exploded. Unfortunately, we were not called to the scene. We might then have found more organs from this diver. On the other hand, the locality was such that parts of him may have been blown straight into the sea.

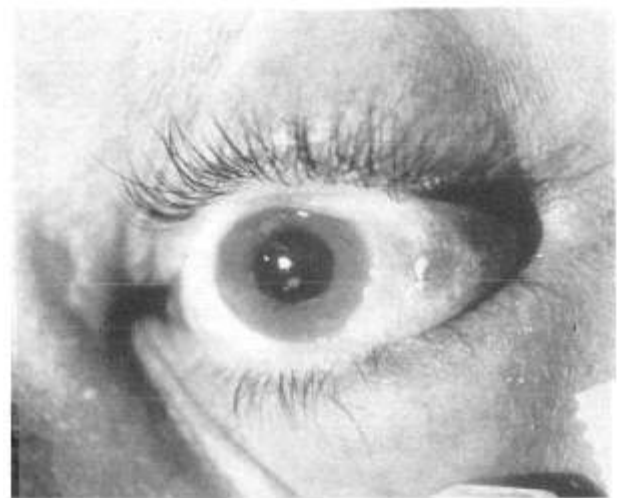
**FIG. 11.** Subconjunctival bulla. Diver 1.

All the organs showed large amounts of gas in the blood vessels, and scattered hemorrhages were found in the soft tissues. One of the divers had a large subconjunctival bulla (Fig. 11).

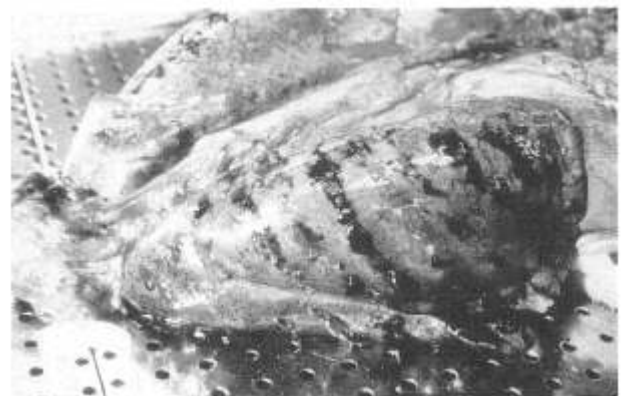
**FIG. 12.** Bandlike subpleural hemorrhages corresponding to the intercostal areas. Diver 1.

The lungs were edematous (1.250 g, 1.350 g, and 1.600 g) with bandlike subpleural hemorrhages corresponding to the intercostal areas (Fig. 12) and with a number of subpleural bullae (Fig. 13). The cut surface showed intrapulmonary hemorrhages.

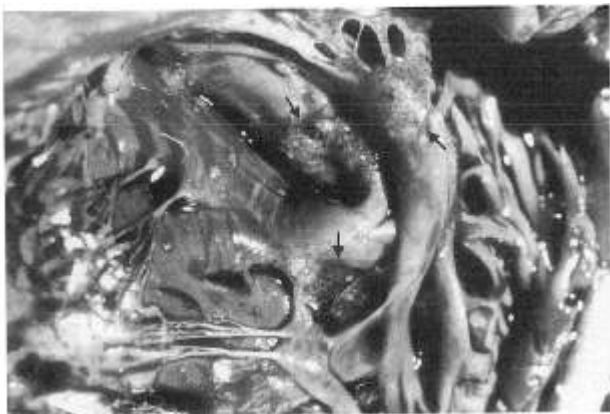
**FIG. 15.** Cardiac chamber with large amounts of free fat adhering to the papillary muscles (arrows). Diver 1.

In the cardiac chambers and in the great vessels around the heart, both arteries and veins, large amounts of free fat were found (Fig. 15). This fat was mixed with gas bubbles, and looked like sizzling butter on a frying pan.

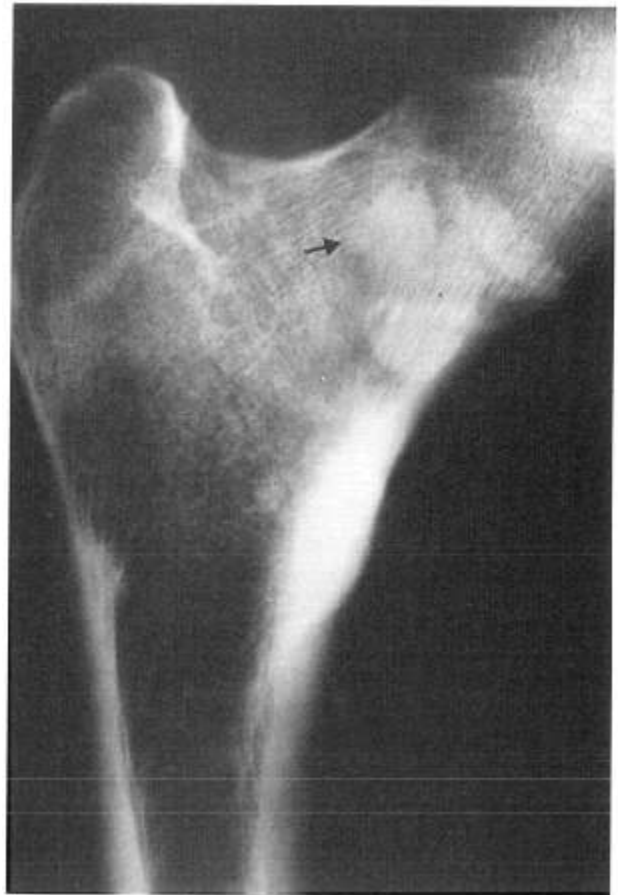
**FIG. 20.** Dysbaric bone necrosis in right femoral neck (arrow).

In diver 2, an area of increased density of the bone structure  $\sim$ 10 mm in diameter, was present in the neck of the right free dissected femoral head (Fig. 20). This

area was cut out. Grossly, no pathologic changes were observed. Microscopic examination revealed some thickened trabeculae due to the apposition of new bone. In some areas of the original trabeculae, the lacunae appeared empty (Fig. 21). This was interpreted as an aseptic bone necrosis.
